SUPERHEATER TUBE CORROSION ON MUNICIPAL
SOLID WASTE FIRED BOILERS AT NASHVILLE

R.S. Rochford
Manager, New Products Engineering

S.J. Witkowski
Product Development Engineer
Industrial and Marine Division, Power Generation Group
North Canton, Ohio

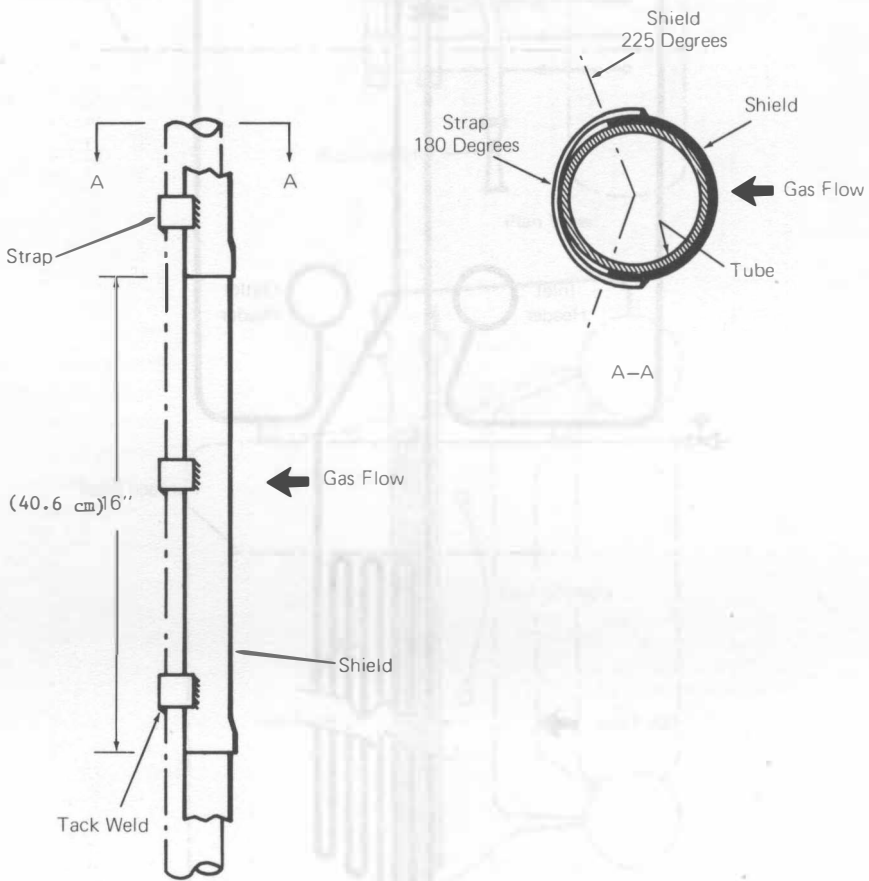
Figure 4

Another feature tested on this superheater was shields. The first tube facing the furnace in Section No. 9 was protected with 14GA, TP-310 stainless steel shields constructed as shown in Figure 4. The tubes in this section were made of the normal SA-178A tube material as used throughout the rest of the superheater. The tube surface under the shield was examined about one year later and it was found to be in excellent condition. No evidences of corrosion were noted.

Arrangement of superheater tube shield

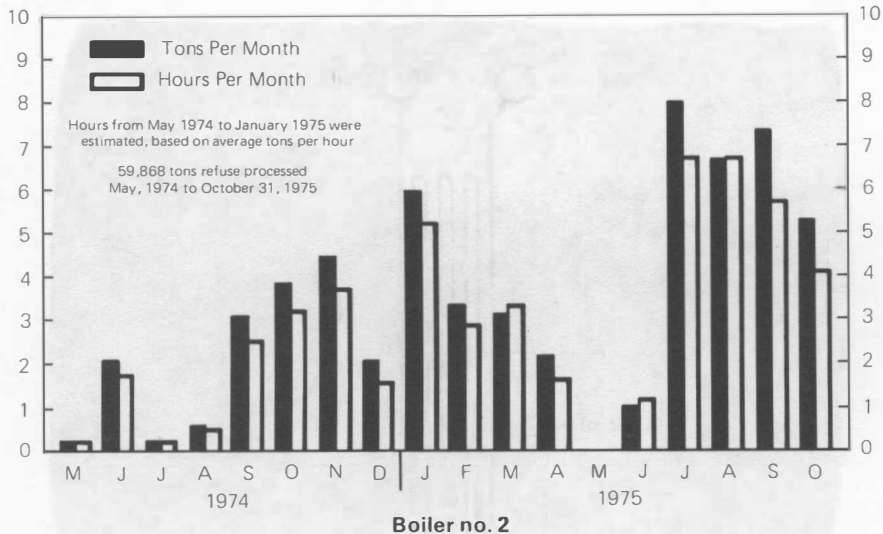
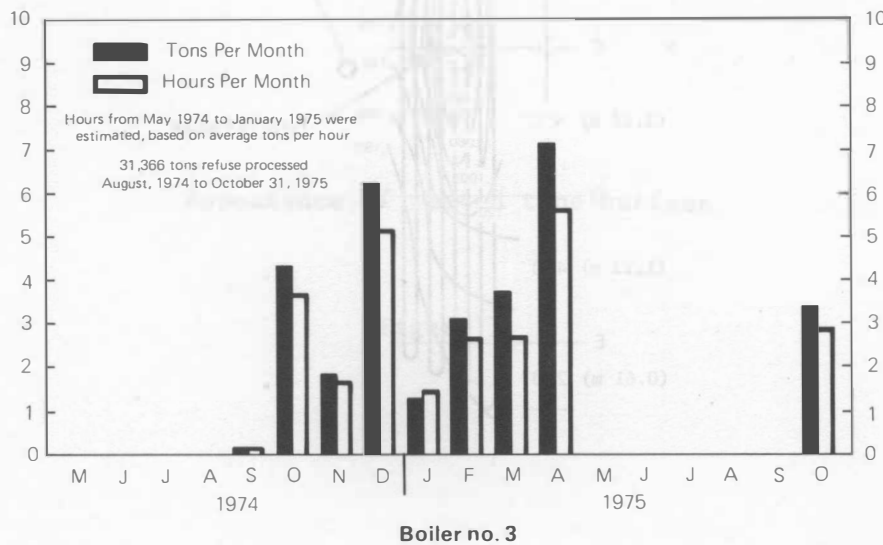
Figure 5 gives a pictorial view of the operation of the refuse boilers from May, 1974 to October, 1975. In February, 1975, the first tube failure occurred in the sidewall of No. 3 boiler. At the time it was speculated the wastage may have been caused by high temperature corrosion and out-of-service corrosion. Cause for the latter speculation arose from the appearance of the ash on the walls. The ash was hygroscopic and many rivulets of rusty liquid could be seen on the surface of the ash covered tubes. Scabs of ash on the tubes covered rusty attacks on the tube surfaces.

Operating history

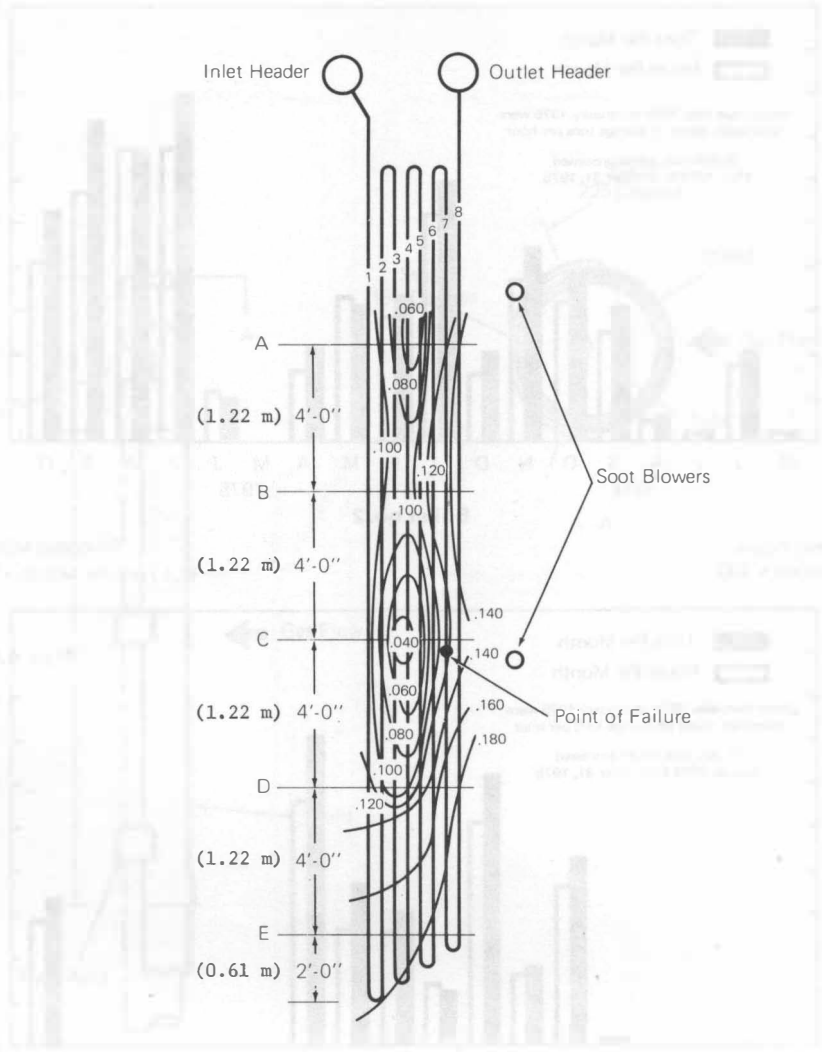
Extensive examinations were performed on Section No. 4 at Alliance. To permit a comparison of the extent of wastage at various positions on the section from top to bottom, five locations were examined. These locations shown in Figure 6 were identified as locations, A, B, C, D and E,

and the tube rows at these locations front to back, as Rows 1 through 8. A three-inch long ring segment was removed from each of the eight tubes at each of the five locations, 40 samples total. The samples were cleaned with inhibited acid and visual and low powered magnification examination showed that all 40 samples displayed some degree of external wastage. The thickness of each sample was taken on all four sides of the tubes and reported in Table 2. A pictorial representation of the wastage on this section is shown in Figure 6. The figure shows lines of equal thickness based on using the average thickness of the sides of each of the 40 samples. It shows the failure was near the lower soot blower and was due to severe external surface metal wastage. However, the maximum loss of metal occurred near the center of the section. A review of the table also indicates that the most severe wastage was on the sides of the tubes and that it was not uniform on both sides of the tube. A close look at one tube as seen in Figure 7 showed uneven surface attack resulting in a general metal roughness.

The laboratory metallurgists reported that their examination revealed the external surfaces were covered with relatively heavy striated deposit layers. The attack on the metal under this deposit displayed a general transgranular attack typical of chemical or solution type wastage. No evidence of intergranular penetrations was observed nor were there any indications of overheating. Since the deposits had various mixed alkalis and metal sulfates with significant chlorine, it was concluded that chlorides were strongly associated with this observed corrosion attack.

Wastage pattern

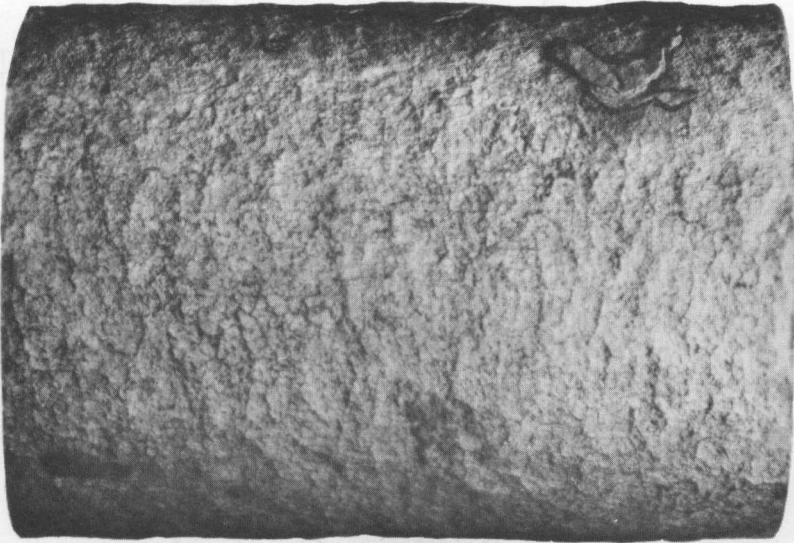
Figure 7

Appearance of wasted tube surface

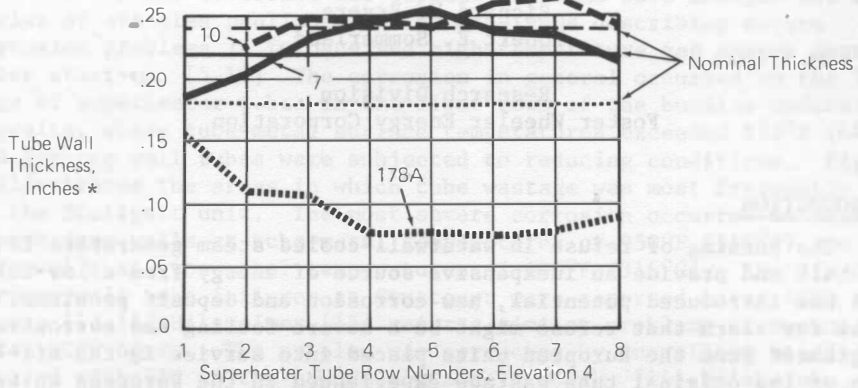
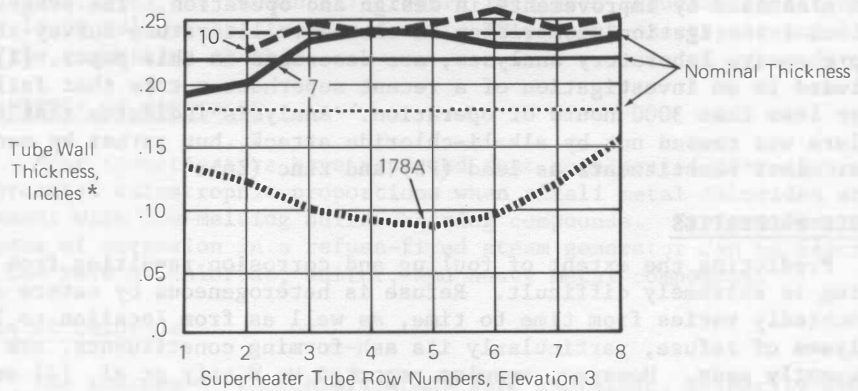
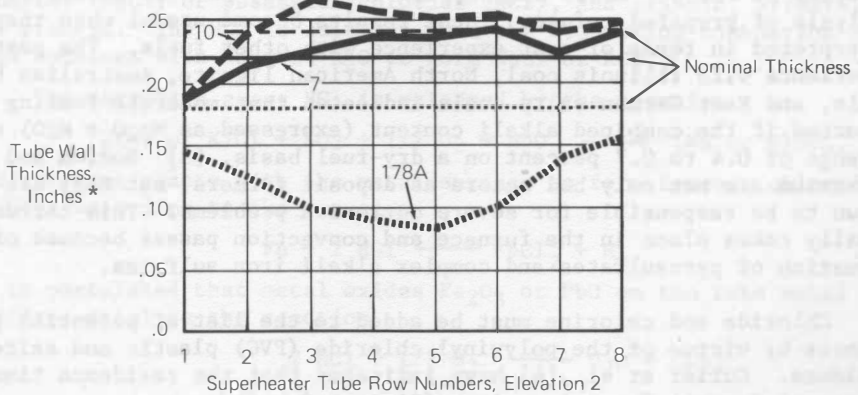
Figure 9

The superheater sections near the sidewalls experienced less wastage than the other sections due to decreased gas flow and temperature. However,

the wastage pattern shown was representative of the physical condition of the superheater as it existed at that time.

These data, Figure 9, show that the production sections experienced the greatest loss of metal in the center of the section, tube Nos. 2 and 7 inclusive, with tube Nos. 3 to 6 being hardest hit. The test sections which operated at higher steam temperatures had less wastage overall. These sections in direct contrast to the production sections looked best or experienced minimum wastage in the center tube row Nos. 3 to 6 inclusive. Superheater section Nos. 7 and 10 show the most loss of metal on the entrance to row Nos. 1 and 2 where gas temperature is greatest.

On an individual tube basis, the wastage pattern was not the same on each side of the tube. It varied from section to section and elevation to elevation. In general, it can be said that the pattern appeared to fit the fact that all superheater sections did not hang in a true vertical position.

Tube wastage

Test sections vs production sections
