FURNACE-WALL CORROSION IN REFUSE-FIRED BOILERS

P. L. DANIEL

Babcock & Wilcox
Alliance Research Center
Alliance, Ohio

ABSTRACT

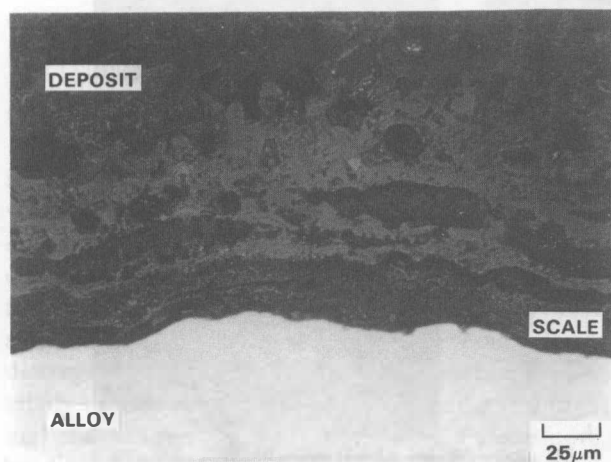
FIG. 2 PHOTOMICROGRAPHS OF THE FIRESIDE DEPOSIT AND SCALE ON THE REAR WALL TUBE

A rear wall tube from the subject unit was examined in the laboratory. The tube had been in service since the original unit startup in July, 1984. It was in service for approximately 6 months during which time it had suffered a 25%, 40 mil (1.0 mm) loss in thickness or a corrosion rate of 80 mpy (2.0 mm/year). When received for laboratory analysis, the tube retained a sooty external deposit. When one gram of deposit was dissolved in 100 g of water, the resultant solution had a pH of 4. The tube surface was generally rough and pitted.

Photomicrographs depicting the nature of the fireside corrosion and associated deposit morphology are shown in Fig. 2. The deposits were porous, grey in color, and multi-layered. A layer of protective iron oxide scale, adjacent to the tube metal, was not always visually apparent. The rearwall tube deposits were generally adherent and were measured from cross sections to be approximately 20 mils (0.5 mm) thick.

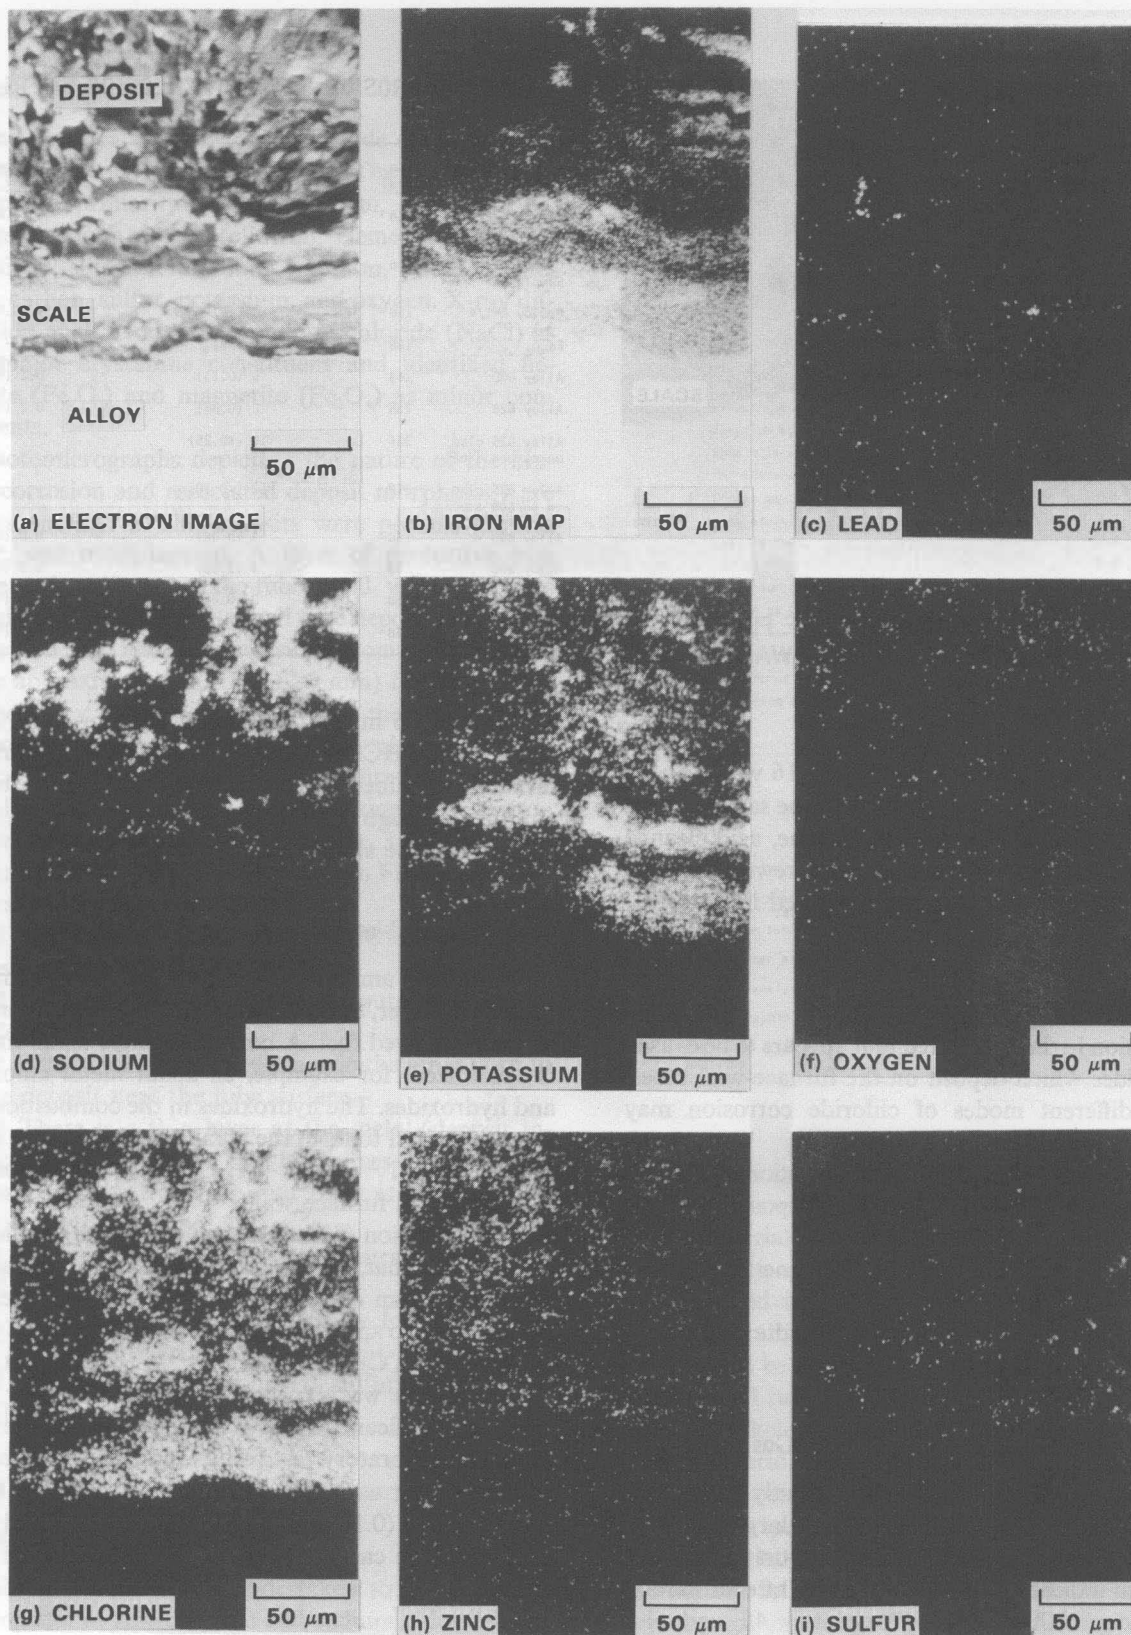
FIG. 3 ELEMENT MAPS OF REAR WALL TUBE DEPOSIT AT THE METAL/DEPOSIT INTERFACE. THIS AREA IS THE SAME SHOWN IN THE PHOTOMICROGRAPHS IN FIG. 2.

The x-ray scanning capability of the electron microscope was used to determine the relative distribution of several elements in the fireside deposits. Resultant x-ray fluorescence maps, along with electron images of the area, are shown in Fig. 3.

Examination of the element maps in Figure 3 reveals several patterns:

- (a) Chlorine and zinc are distributed throughout the deposit.
- (b) Sodium is more abundant in outer portions of the deposit.
- (c) Potassium is more abundant in the inner portion of the deposit near the tube surface.
- (d) There is a thin layer at the metal/deposit interface that is iron-rich. This layer does not appear to be associated with oxygen, but there is a definite association with chlorine.
- (e) Lead, while scarce, is concentrated near the metal/deposit interfaces.
- (f) Oxygen is present in relatively low concentrations uniformly distributed throughout the deposit.
- (g) Relatively small amounts of sulfur are randomly distributed through the deposit.
