AIR POLLUTION CONTROL RETROFIT SIX YEARS LATER— ELECTROSTATIC PRECIPITATORS ON ROTARY KILN INCINERATORS

JOHN W. NORTON

ABSTRACT

Update on status and repair history of retrofitted incinerator with new electrostatic precipitator systems. Author revisits the previous subject of 1984 ASME paper titled, "Modern Air Pollution Control Retrofits: The Potential for Recovery of the Incinerator Itself."

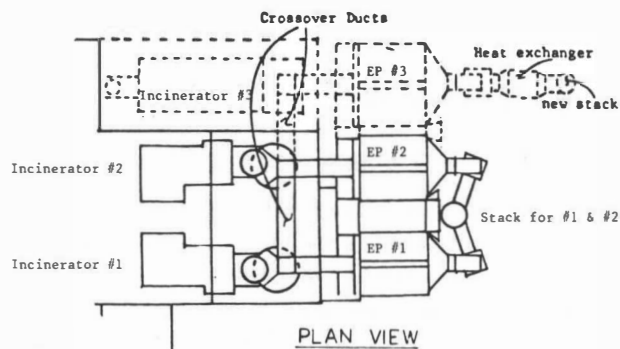
FIG. 1 PLAN VIEW SHOWING CROSSOVER DUCTS BETWEEN EXISTING INCINERATOR EQUIPMENT TRAINS AND PROPOSED NEW THIRD INCINERATOR EQUIPMENT TRAINS

Rapping Problem”. At first, even the Regional Air Pollution Control Agency was confused about the source of little black flakes ($< \frac{1}{16}$ in. or < 1.0 mm) that were discovered on an irregular basis in isolated areas perhaps one-half to three-quarters of a mile (800–1200 m) from the North Plant. Oddly enough, the Regional Air Pollution Control Agency first suggested that these little black flakes “could not possibly” have emanated from the incinerator. The Plant Manager, however, was able to note certain patterns with regard to the disposition and location of these particles. With the assistance of a windsock installed at the Plant and a review of operating records, he was able to ascertain that the particles appeared down wind from the incinerator following rare combustion problems at the Plant. The particles seemed to form during infrequent periods of bad combustion and were released during rappings of the third field of the electrostatic precipitators. This theory was tested by “bottling up” the precipitator during rappings of the third field. The occurrences of these little black flakes in locations around the Plant stopped.

This problem only appeared after infrequent rapping of the third fields. It appears that the third field would catch the emissions from the first and second fields during their rappings, but when the third field rapped, there was nothing to prevent loss of the flakes (if they were present on the third field plates.) During normal times—with “good” combustion—this problem did not occur even when rapping the third field.

In order to solve the third field rapping problem, it was necessary to install "a crossover duct." This is a 60 in. \times 60 in. (1.5 m \times 1.5 m) duct joining the two incinerator trains after the wet conditioning tower. See Fig. 1. Slide gates allow use of the duct during third field rapping. The slide gate in the crossover duct allows isolation of the two systems during normal operation.

In order to maintain a 350°F (177°C) temperature in the crossover duct to prevent acid condensation, the crossover duct included a 12 in. \times 12 in. (0.3 m \times 0.3 m) duct which by-passes the slide gate in the crossover duct. While there is a small slide gate in this bypass duct, it is kept open at all times. The slight difference in pressure between the two incinerators causes a flow of gases through the crossover duct (and its little bypass duct) continuously—thus ensuring that the gas temperature within the duct is maintained at a relatively high temperature.

The crossover duct was included in the South Incinerator retrofit at the beginning. No such complaints have been registered about flakes in the vicinity of the South Plant. New third incinerator lines under construction at each plant, include crossover ducts which will allow interconnection of the third unit to the existing units. See Fig. 1.

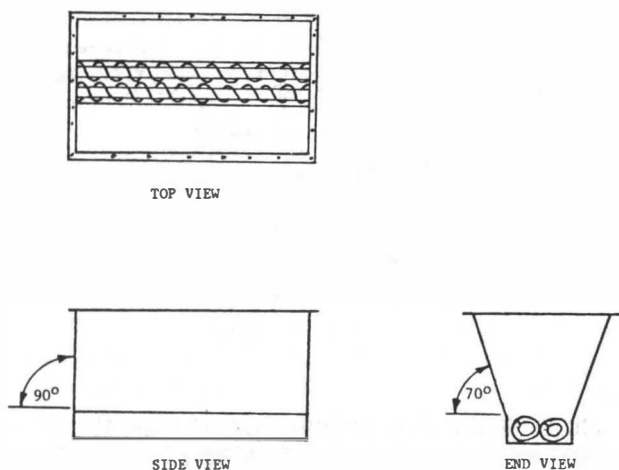
FIG. 2 DOUBLE SCREW HOPPER BOTTOMS
 (Note: Increased Side Wall Angles of Repose to Reduce Plugging by Fly Ash)

Hopper Plugging with the captured fly ash has been a nuisance problem despite steep (60 deg.) sidewall slopes and bin heaters and vibrators which were included in the original retrofit. Its solution has been one of checking the hoppers shortly after start-up. Hopper plugging has been most severe within 24 hr of a cold start-up.

New precipitators for the third units at each plant include steepened hopper side slopes (from 63 deg. to at least 70 deg.) and double screw conveyers at the bottom as shown in Fig. 2. End slopes in the hoppers have been increased to 90 deg. for the new hoppers, thus avoiding the shallower slope which results at the compound joint between end walls and side walls.
