FIRESIDE TUBE CORROSION IN AN INDUSTRIAL RDF-FIRED BOILER — KODAK'S EXPERIENCE

ROBERT D. BLAKLEY

Eastman Kodak Company
Rochester, New York

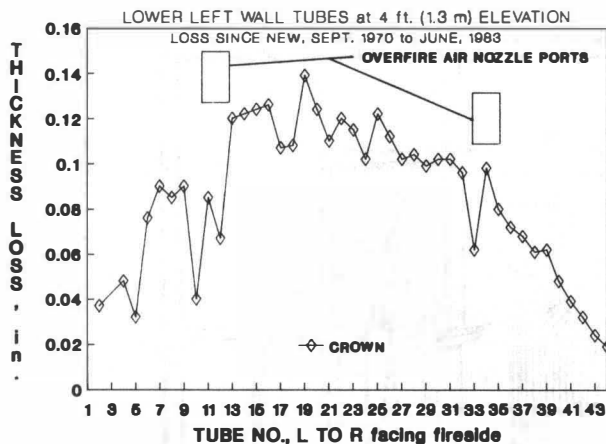
FIG. 2 ORIGINAL FURNACE WALL TUBES—WASTAGE VS TUBE NUMBER

Ultrasonic thickness measurements of the furnace wall tubes have been recorded since 1970 when the boiler was first placed into service. Significant thinning [more than 0.050 in. (1.3 mm)] was noticed after tube leaks developed near the corner burner/windboxes. The serious rate of deterioration occurred after 3–9 months of cofiring waste solvent. This wastage slowed after solvent burning was discontinued in 1976. However, the damage remained (in the form of thinned tubes) until replacements in 1987 and 1988.

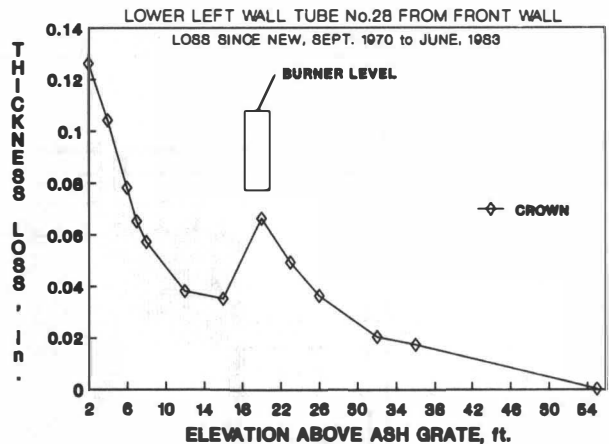
FIG. 3 ORIGINAL FURNACE WALL TUBES—WASTAGE VS ELEVATION

(b) Furnace waterwall tube deterioration typically decreases with height above the grate (Fig. 3). Note the significant reduction in metal loss above the 12 ft (4 m) elevation.

The increased wastage at 19 and 23 ft (5.8 and 7.0 m) elevations includes some thinning from the brief period of solvent firing in 1975–1976.

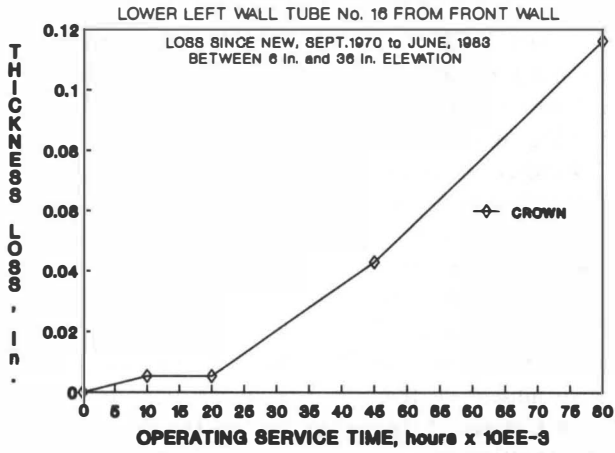
FIG. 4 ORIGINAL FURNACE WALL TUBES—WASTAGE VS TIME

Note the dramatic rise coincides with increased refuse quantities burned for longer periods of time between boiler outages, starting in 1975.

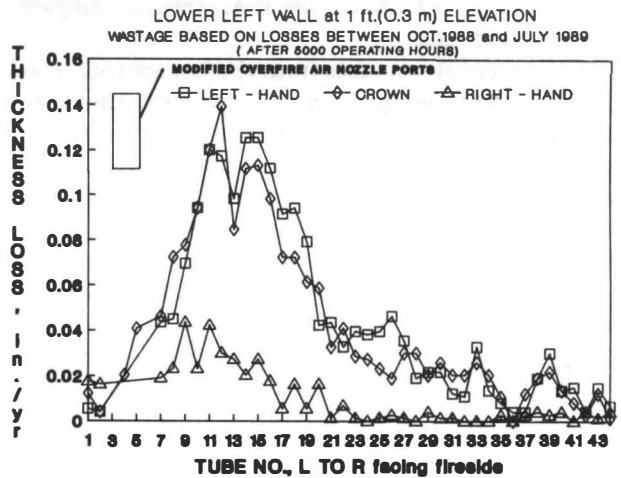
FIG. 7 HEAVYWALL/OVERSIZE TUBES WASTAGE VS ELEVATION

Oversize, heavy wall carbon steel tubes [2.625 in. O.D. x 0.270 in. nominal thickness (66.7 x 6.9 mm)] replaced deteriorated left and right sidewalls in October, 1988. More restrictive overfire air nozzles were also retrofitted at that time. Readings after several months of service indicate severe localized thinning on the left and crown surfaces of these tubes near the grate (Fig. 7). Standard [0.210 in. (5.3 mm) nominal] thickness tubes in the lower front and rear waterwalls

have also shown similar patterns of wastage, albeit at smaller rates [up to 0.120 in. (3.0 mm) loss in 2 years] since replacement in August, 1987.

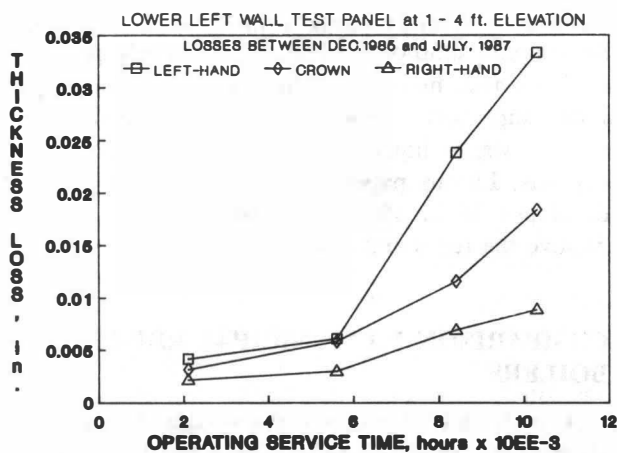
FIG. 8 CHROMIZED FURNACE WALL TUBES—WASTAGE vs TIME

Table 1 summarizes Kodak's evaluations of these methods. Figure 8 shows how the chromized tubes' wastage rates increased with service time and preferential thinning of the left-hand and crown portions of the tubes, similar to the carbon steel waterwalls.

b. Stainless Steel "444"	Lower Superheater & Burner Area	1980-1981	Significant lack of bonding after 3500 hours of boiler operation.
c. "Chromized" Test Panel, 9 Tubes Wide ⁽¹⁾	Lower Furnace (Left Waterwall)	1985-1988	Brazed sst fiber-rein. refractory failed to remain bonded after 2100 hours. Fused WgC coating suffered minor lack of bonding. Chromized layer reduced wastage rates initially but effectiveness lasted only 10,000 boiler operating hours (18 months) (Figure 8).
