MANAGING TUBE METAL WASTAGE IN RDF-FIRED BOILERS AT ELK RIVER STATION

TIMOTHY P. STEINBECK

United Power Association
Elk River, Minnesota

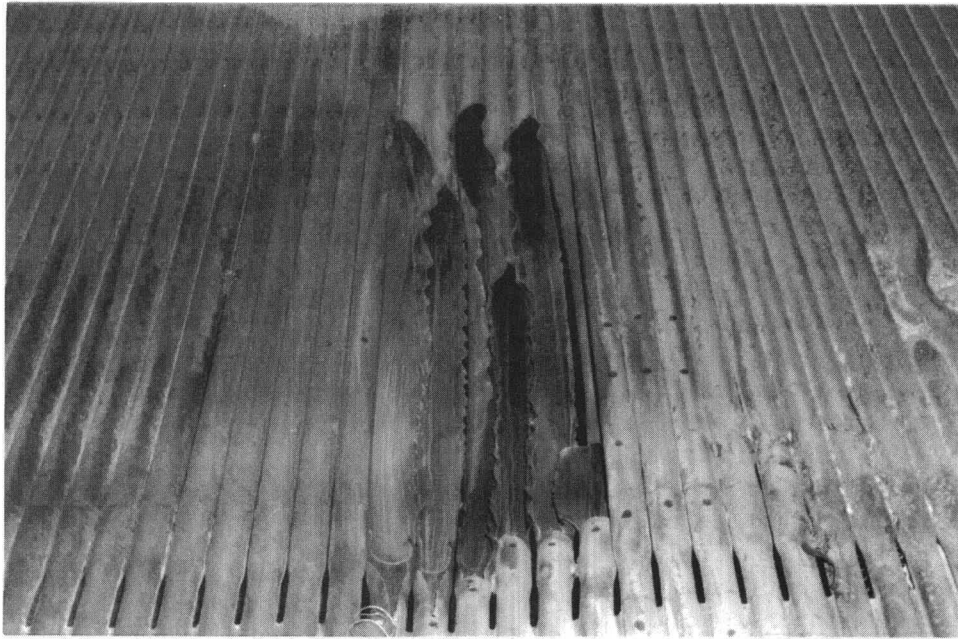
On June 10, 1990 Unit 3 boiler experienced a simultaneous failure of six water wall tubes (Fig. 3). The subsequent furnace pressurization caused the boiler casing to buckle and bulge and several buckstay supports to bend. Fortunately, no personnel were injured in the incident.

The tube leaks occurred on the right side wall 13–19 ft above the grate elevation. This was in the area of the original boiler wall tubes (0.180 in.) and was significantly higher than any of the areas inspected during the first year of operation. The tubes that failed were thinned to a tube wall thickness of 0.040 in. due to extreme tube wastage in the area. Visual and UT inspections showed that there was general tube wastage on the lower 24 ft of the right side wall of up to 0.150 in. Fig. 4 shows the general pattern of this wastage. The left wall was not as severe but had some tube wastage of up to 0.100 in. The worst wastage on both side walls was 12–15 ft above the grate and near the center of the wall. The front and rear walls showed very little wastage.

FIG. 3 UNIT 3 TUBE FAILURES, JUNE 1990

Due to the extreme rate of corrosion (+0.010 in./month) on the side walls, it was decided that the boiler could not return to service unless the thinnest areas were repaired. The repair options were evaluated and it was decided that padwelding over the existing tubes with a chrome/nickel alloy would be the best immediate fix. Due to the positive reports from the industry, Inconel 625 alloy was chosen as the overlay material. The Inconel electrode was applied manually by downhand, electric arc welding. About 840 esf of overlay was applied to both side walls in 17 days while the failed tubes and casing were replaced.

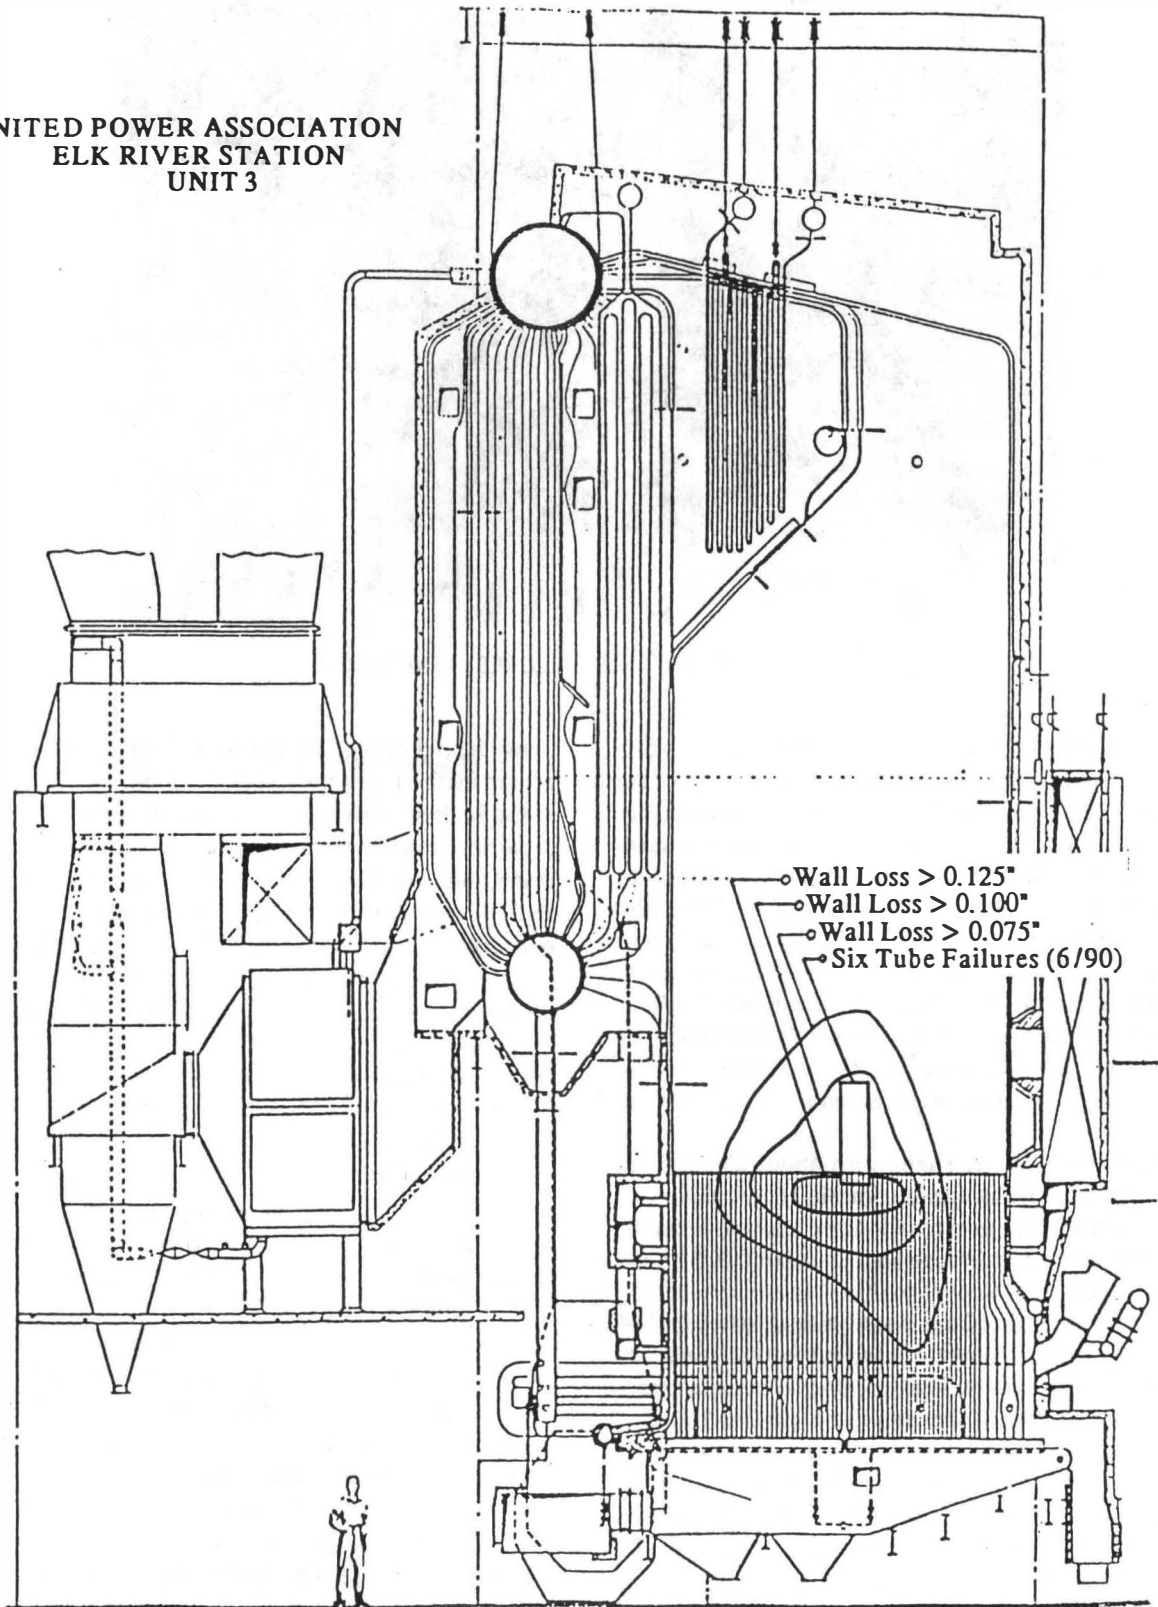
FIG. 4 UNIT 3 RIGHT SIDE WALL — PATTERN OF TUBE WASTAGE
