Electrostatic Precipitator Maintenance Process Re-Engineering: Lead & Cadmium exposure control at the Hampton/NASA Steam Plant.

**John S. Austin, P.E.
50 Wythe Creek Road
Hampton, Virginia**

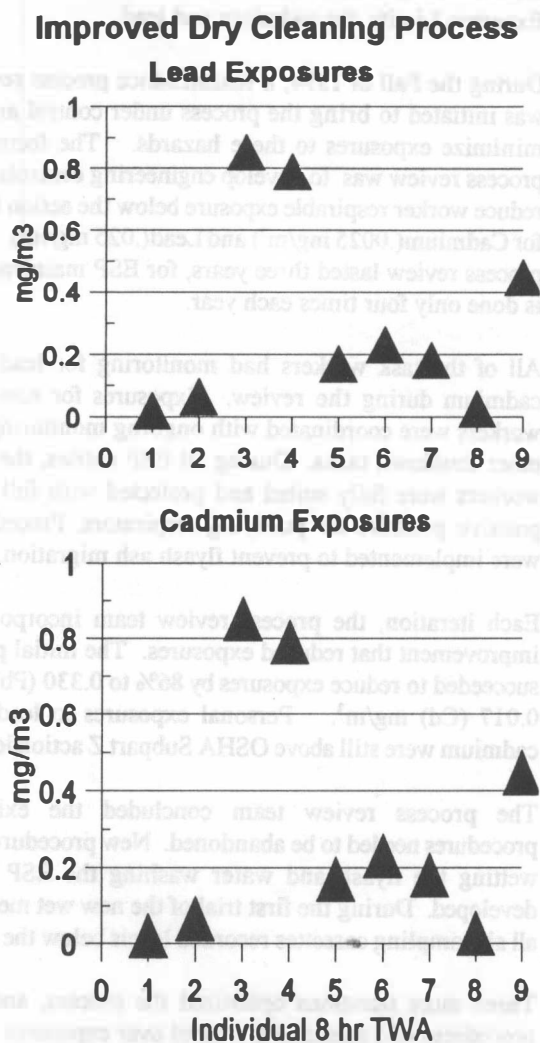
Figure 1: Worker exposure during dry cleaning ESP.

The process was still out of control. Individual task worker exposure varied greatly; standard deviation of the samples for both lead and cadmium were greater than the PEL's. Exposures were reduced 86% to 0.330 mg/m³ of lead and 0.017 mg/m³ of cadmium, these exposures were still above OSHA Subpart Z action levels.

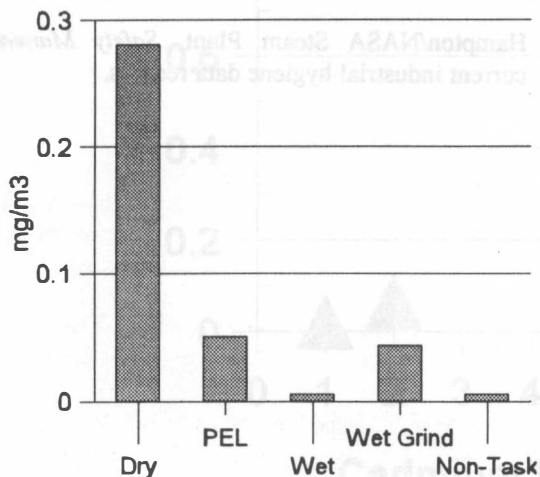
Figure 2: Lead Exposures

The results of wet methods were procedures that consistently reduce exposures during and after cleaning to below the action levels. The wet grinding procedure reduces lead levels to below the PEL, but above the action level. ESP grinding tasks are very infrequent, so it may take years to accurately quantify exposures. The summary of results are presented in Figures 2 and 3.

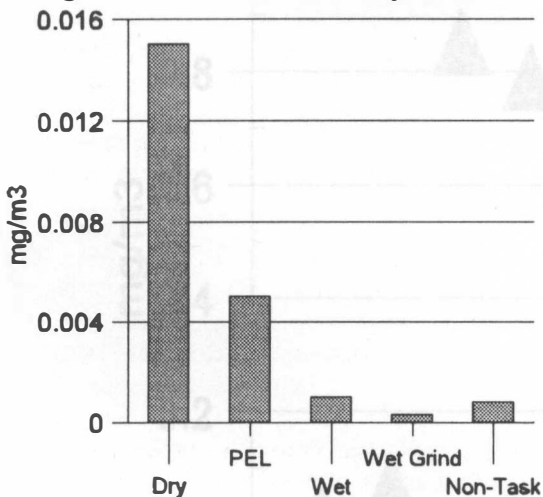
Figure 3: Cadmium Exposures

Most cadmium samples for the wet methods and the non-task incidental exposures were reported at a non-detect level. Time weighted averages for these varied based upon the sampling and task durations. The wet grinding procedure controls cadmium, but the lead absorbed into the metal causes lead exposure above the action level.
