UPDATED CASE STUDY OF FIRESIDE CORROSION MANAGEMENT IN AN RDF FIRED ENERGY-FROM-WASTE BOILER

Steve Vrchota
Great River Energy
Elk River, MN, United States

Tim Peterson
Great River Energy
Elk River MN, United States

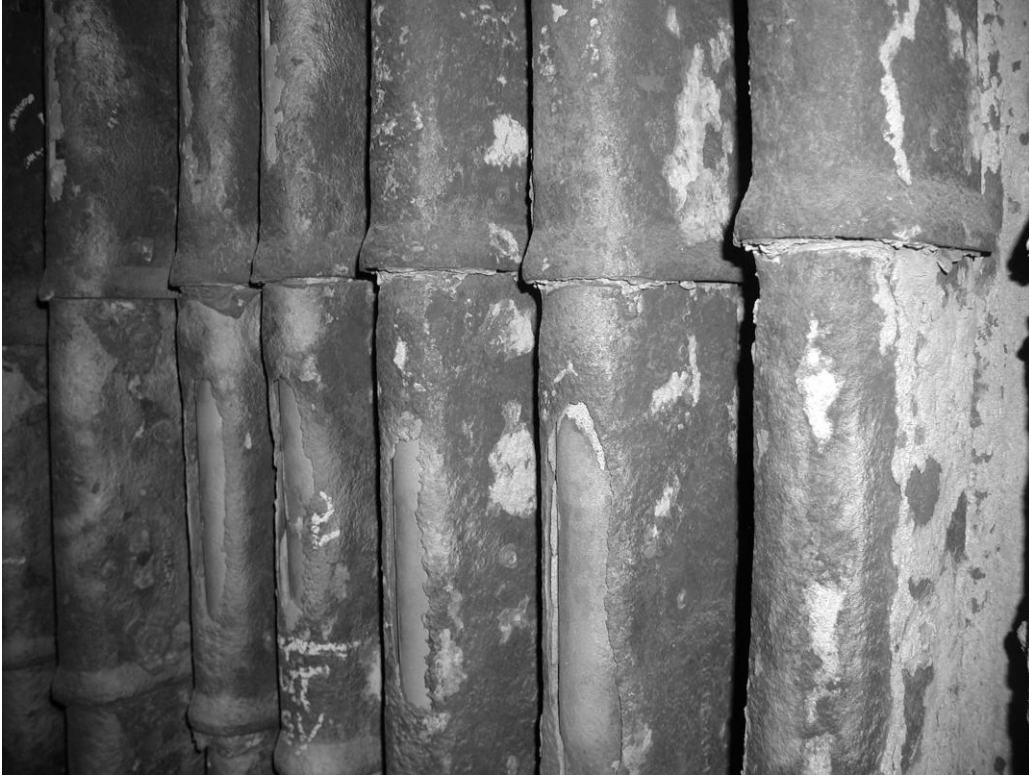
Tube wear can exceed 200 mpy (5 mm/y) in the sootblower lane and 80 mpy (2 mm/y) in the body of the main pendants. Tube wear in the sootblower lane was relatively independent of tube material with 310 SS only having about a 20% reduction in wear rates as compared to T-22 material. Tube shields operate at elevated temperatures relative to the tubes due to poor heat transfer to the tubes and even higher wear rates occur. Wear rates of shields in the sootblower lane exceed 300 mpy (7.5 mm/y) and are relatively independent of the shield material. Different materials have been tested for shields including 310 SS, RA 85H, RA 253, HR-160 and Haynes 556. Results varied slightly for each shield lasting from 3-5 months, but nothing lasting a 1 year outage cycle. Typical rolled shields that are 10 gage (3 mm) thick and are constructed of 310 SS material last less than 4 months in the sootblower lane.

FIGURE 1- INSTALLED HIGH TEMPERATURE SUPERHEAT SHIELDS AFTER 1 YEAR OF OPERATION

Since the wear in the sootblower lane area is far greater than the general tube wear, shields were required that would last one year to allow them to be replaced during annual outage cycles. Wear rates require shields that exceed 0.300 inches (7.5 mm) thick to last in the highest wear areas. Cast tube shields were

chosen because rolled shields are not available in this thickness. Cast shields made out of HD stainless cast in the shape of a “U” were selected and installed in 2003. HD stainless steel contains 27% chrome and 5% nickel with the remainder mostly iron. The shields shape allows it to protect the first two tubes. The shields are installed with heat transfer silicon carbide cement to increase cooling of the shield. The tube shields have proven to survive approximately twelve months of service. Figure 1 shows a typical high temperature superheater shield installation. The shields were replaced on all boilers from 2003 to 2009 on an approximately annual basis. In Units 1 & 2, the shields were mostly intact at the end of a one year cycle. The shields in Unit 3 lasted a full year in 2003 and 2004 but showed signs of increasing wear. By 2009 the shields in Unit 3 were providing adequate protection for only about 9 months.

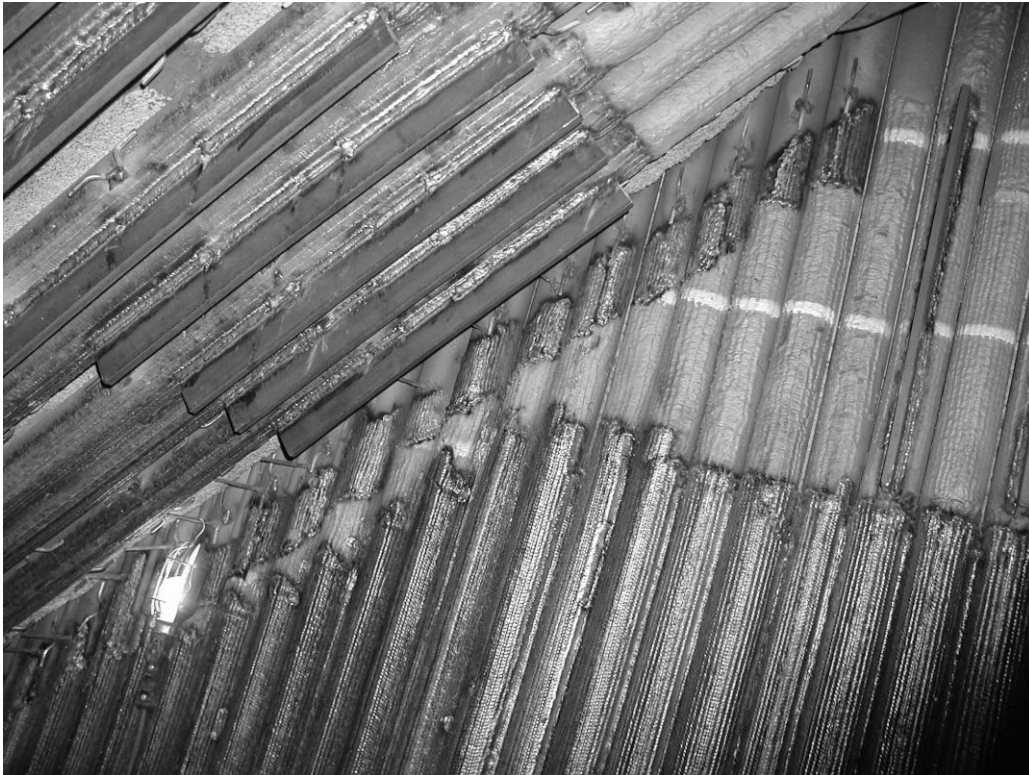
During the 2003 annual outage, approximately 850 lbs (386 kg) of iron bars (1/2”x2”x24”) were installed on the clad tubes just upstream from the carbon steel surface in Unit 3. Figure 2 shows the installed iron bars. During one year of operation, about 75% of the sacrificial bars were corroded away. Results have shown that corrosion is reduced around and downstream of the bars. On a furnace wall area that had lost up to 0.100 inches (2.3 – 2.5 mm) from 2002 to 2003, the largest loss was 0.025 inches (0.64 mm) from 2003 to 2004 and affected a smaller area. The sacrificial bars have been replaced on an annual basis to maintain this protection. From 2003 to 2009, only small areas of new Alloy 625 have been required to protect thinning tubes. The average loss of material during this period was approximately 10 mpy (0.4 mm/y). Few areas of accelerated localized corrosion have been recorded.

FIGURE 2- INSTALLATION OF SACRIFICIAL IRON BARS

The corrosion rates on the furnace walls are always highest on the steel closest to the transition from the Alloy 625 cladding. Areas far from the cladding line show no excessive wear. Because iron is very easily oxidized, it was theorized that if the furnace gas was allowed to contact non-pressure part, sacrificial iron before the carbon steel to Alloy 625 interface on the wall, the corrosion would occur on the sacrificial iron and not on the wall tubes. Wall thickness data was used to calculate that approximately 1000 lbs (454 kg) of iron was lost from the water wall adjacent to the Alloy 625 interface in one year.

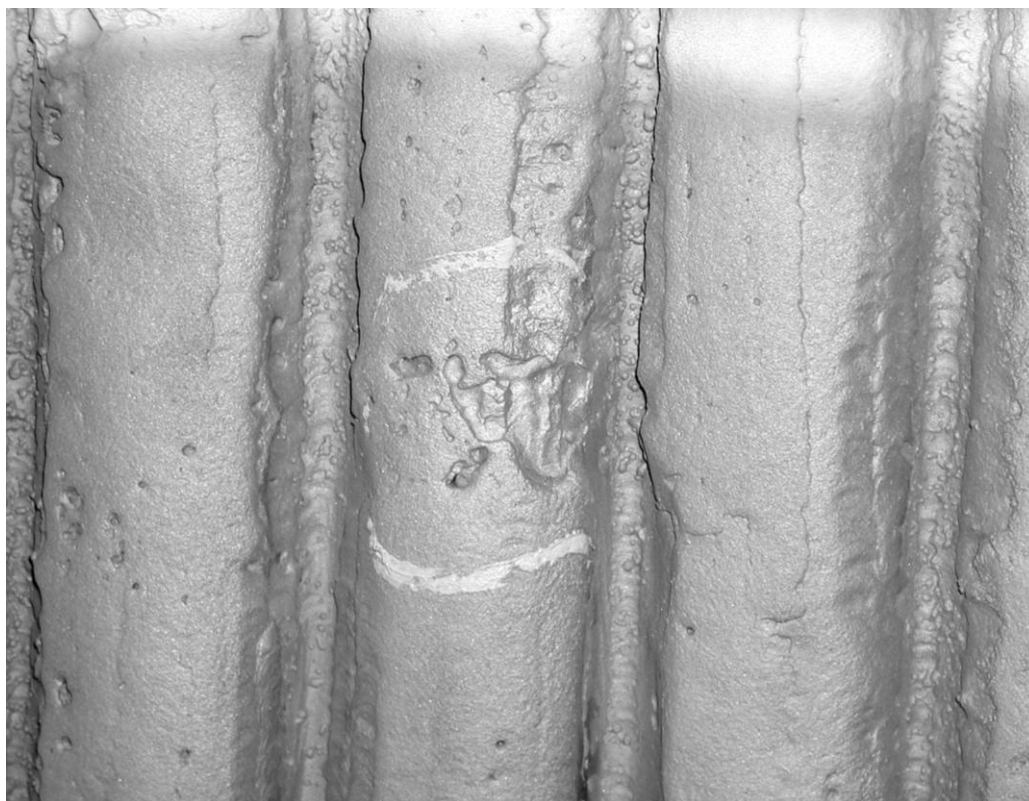
Cracking or spalling of the cladding can also lead to tube leaks. Inspection for cracks and spalled areas is accomplished by first sandblasting the entire clad area to a near white finish. Figure 3 shows typical pitting on the Alloy 625 surface. The cleaned area is then sprayed with a copper sulfate spray which rapidly oxidizes any exposed carbon steel. The oxidized areas show as a bright red finish and are shown in Figure 4 as the darker areas.

FIGURE 3- TYPICAL SURFACE PITTING OF ALLOY 625 SURFACE ON LOWER WATER WALL SECTIONS

Where carbon steel is exposed, the surface is prepared with a grinder and Alloy 625 reapplied. If the base carbon steel tube has excessive metal loss, it is ground down to the carbon steel layer and repaired with carbon steel welding rod. The area is then prepared with a grinder and Alloy 625 is applied as a final layer. It is critical to repair every hole, as even very small

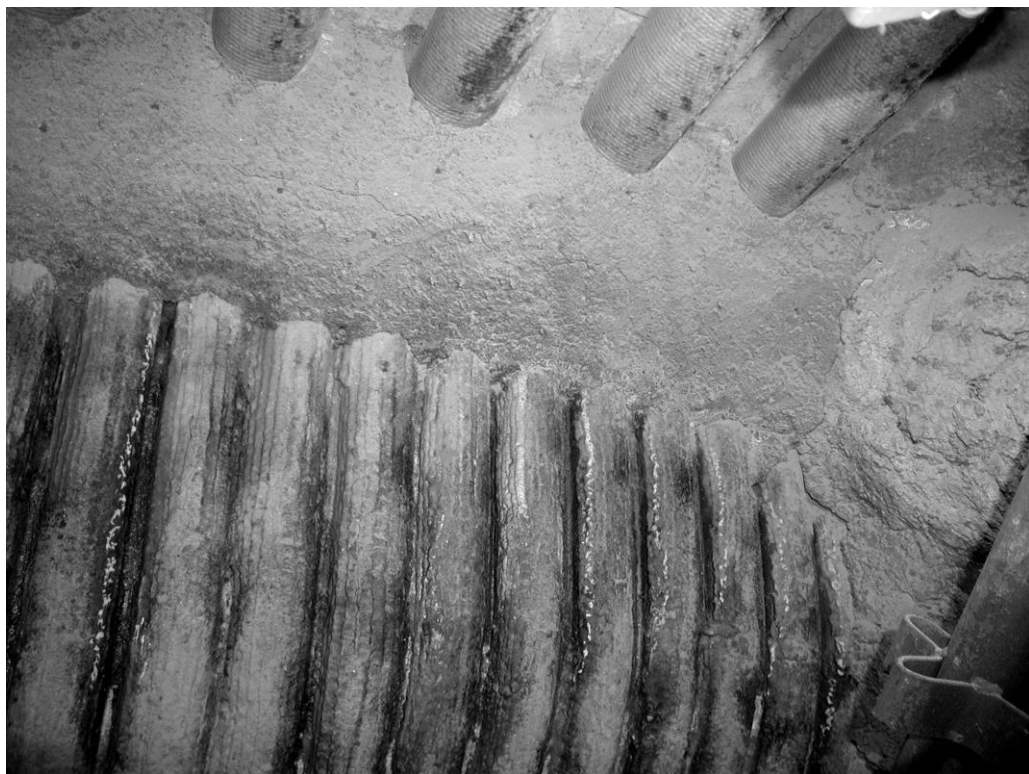
FIGURE 4- SURFACE TREATED WITH COPPER SULFATE
