NAWTEC16-1916

The effects of varied hydrogen chloride gas concentrations on corrosion rates of commercial tube alloys under simulated environment of WTE facilities

Shang-Hsiu Lee and Marco J. Castaldi

Department of Earth & Environmental Engineering (HKSM)
Columbia University, New York, NY 10027

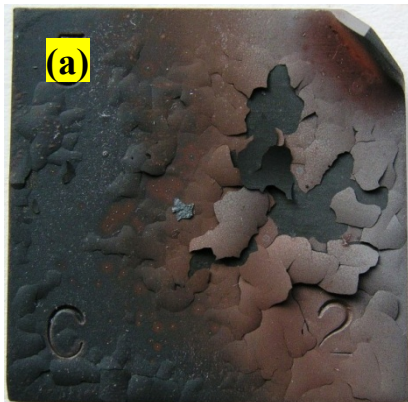
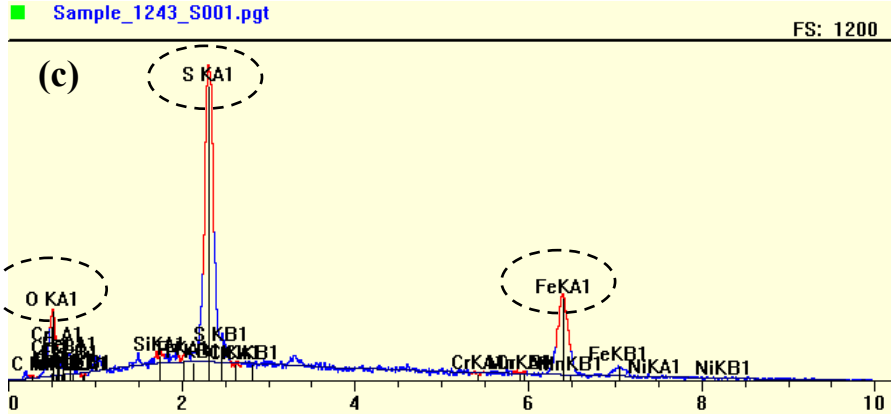
Figure 4a is the image of the sample after the 100 hrs test with metal temperature of 560°C and 1000ppm HCl-containing gases. This sample was more corroded if compared to the sample without HCl-containing gases treatment. The black-reddish scale was thicker and suffered from severe spallation when cooled down. The

SEM image (Fig. 4b) also shows porous, petaline shape oxide on the scale, but unlike the previous sample the scale had high S content except Fe and O (Fig. 4c). In an oxidizing atmosphere the thermodynamic stability of metal chlorides, metal sulfate and oxides at a given temperature depends on the partial pressures of O_2 , Cl_2 and SO_2 . The thermodynamic phase stability diagrams for the system $\text{Fe-O}_2\text{-Cl}_2$ and $\text{Fe-O}_2\text{-SO}_2$ at 560°C are shown as Fig. 5a and 5b in which the equilibrium conditions of the test were marked. According to these diagrams the scale consisted of Fe_2O_3 and $\text{Fe}_2(\text{SO}_4)_3$ which was consistent with the findings from EDS.

Fig. 4 (a) Surface morphology of sample SA178A tested with 1000ppm HCl-containing gases, (b) SEM images of the scale, and (c) Elementary analysis of the scale

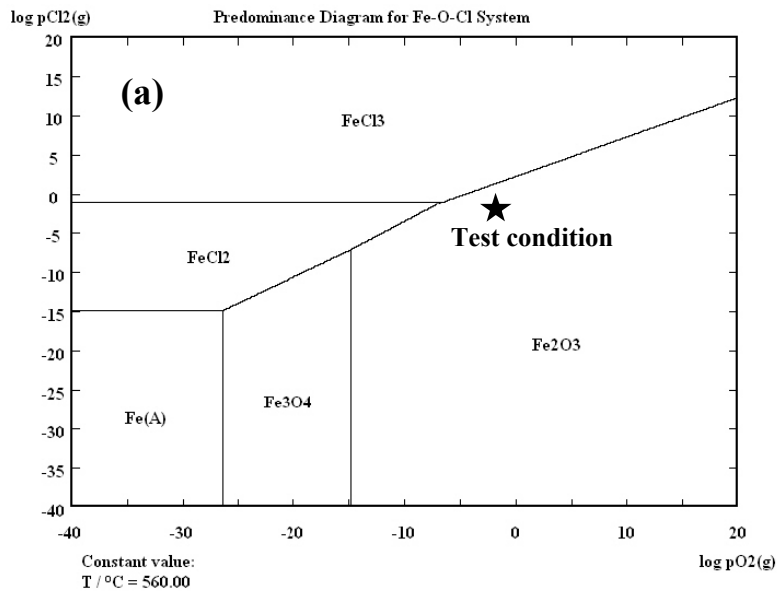
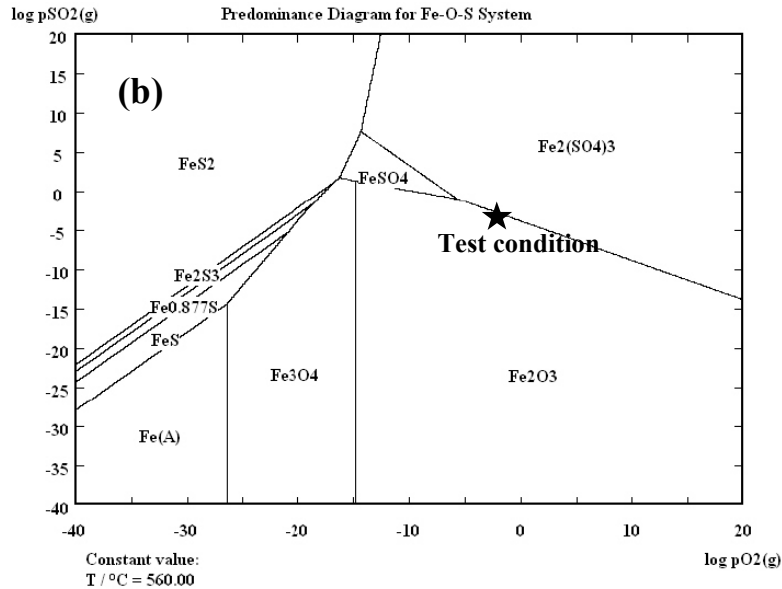
Fig. 5 Thermodynamic stability diagrams of the system at 560°C (a) Fe-O₂-Cl₂ and (b) Fe-O₂-SO₂

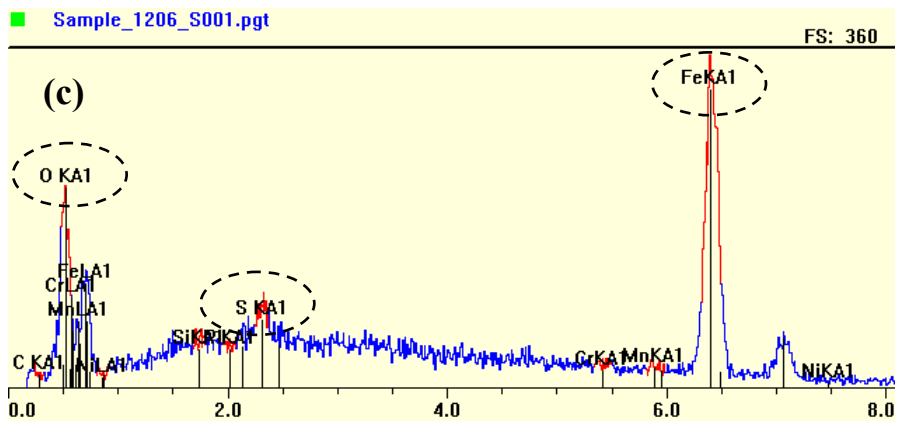
Figure 9a is the image of the sample after the 100 hrs test with metal temperature of 570°C and non HCl-containing gases. The whole metal surface was covered by black-reddish scale which was found very porous and consisted of needle-like oxide whiskers under SEM (Fig. 9b). These oxide whiskers rich in Fe and O with a small amount of S were expected to be Fe₂O₃/Fe₂(SO₄)₃ (Fig. 9c).

Fig. 9 (a) Surface morphology of sample SA213 T11 tested with non HCl-containing gases, (b) SEM images of the scale, and (c) Elementary analysis of the scale

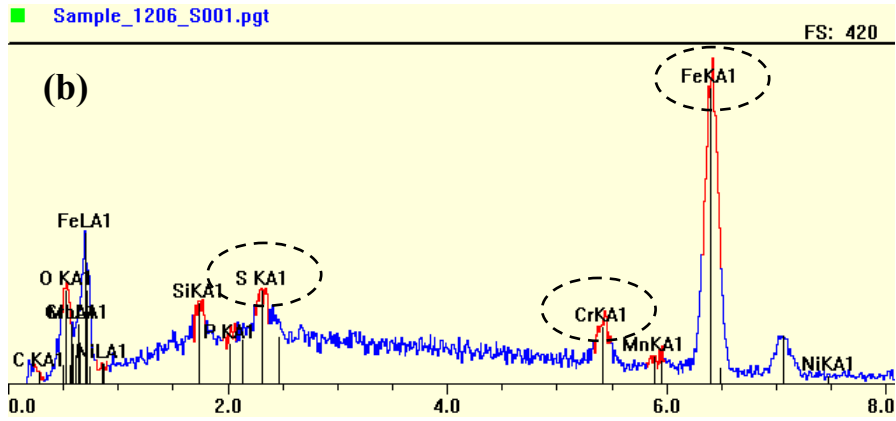
Figure 10a is the SEM image of the same sample after the removal of the scale from the surface. The scale/metal interface was porous and contained some cracks. EDS results showed high Fe and Cr contents which were different from the scale, but the S content was at about the same level (Fig. 10b). The interface was expected to consist of Cr₂(SO₄)₃/Cr₂O₃ and

Fe₂O₃/Fe₂(SO₄)₃. Compared to the results of SA178A, the addition of Cr element to SA213 T11 protected the metal from being further corroded by S.

Fig. 10 (a) SEM images of the scale/metal interface after removal of the scale, and (b) Elementary analysis of the scale/metal interface

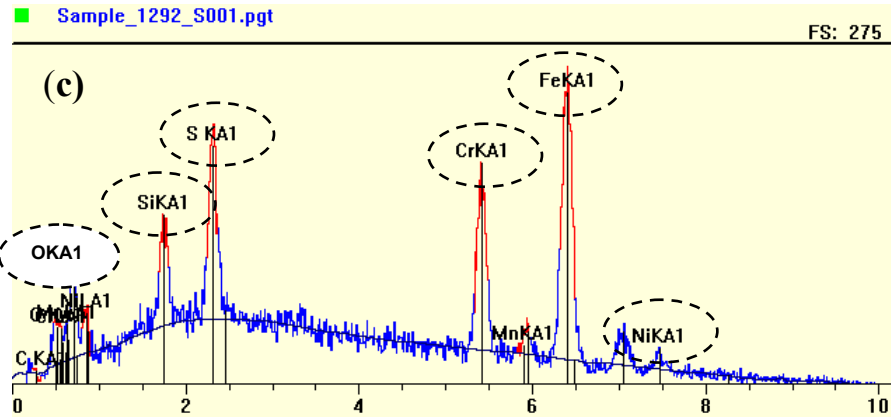
Fig. 15a shows that the sample retained almost its original surface after the 100 hrs test with metal temperature of 575°C and non HCl-

containing gases. The SEM image shows that only a few spots of oxide were deposited on the surface. Except the sample's original elementary composition, O and S were indentified (Fig. 15b and 15c).

Fig. 15 (a) Surface morphology of sample NSSER-4 tested with non HCl-containing gases, (b) SEM images of the scale, and (c) Elementary analysis of the scale

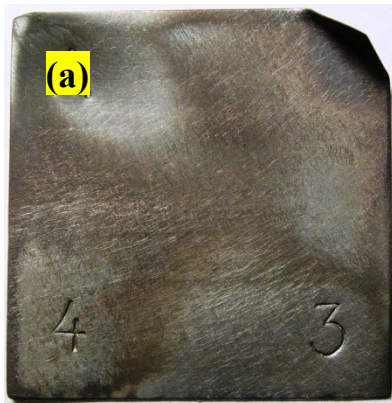
The appearance of the sample tested with 1000ppm HCl-containing gases was similar to the sample without HCl attacks (Fig. 16a), but SEM image shows that many granular crystals which were rich in S were deposited over the all surface (Fig. 16b and 16c). The thermodynamic calculations indicated that the compounds were mainly Fe_2O_3 , $Fe_2(SO_4)_3$, $NiSO_4$, NiO and Cr_2O_3 .

Fig. 16 (a) Surface morphology of sample NSSER-4 tested with 1000ppm HCl-containing gases, (b) SEM images of the scale, and (c) Elementary analysis of the scale

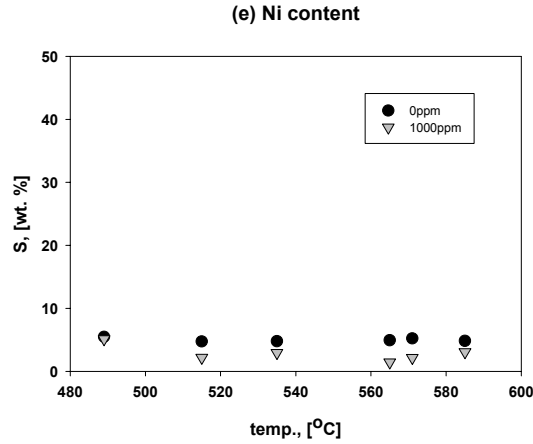
Figure 17 are the comparisons of different elements on the surfaces of scales treated with/without HCl gas. The trends of Fe, O, S and Cr were similar to that shown in sample SA213 T11. The results showed that the formation of NiO and Cr_2O_3 during the corrosion process protected the metal against subsequent S and Cl attacks.

Fig. 17 Elementary analyses of the scales' surfaces; (a) Fe, (b) O, (c) S, (d) Cr, and (e) Ni
