**REAR-VENTILATED BOILER WALL PROTECTION
OR
HOW TO REDUCE MAINTENANCE COSTS**

Stephan Mulch
Juenger + Graeter
D-68723 Schwetzingen, Germany

Markus Horn
Juenger + Graeter
D-68723 Schwetzingen, Germany

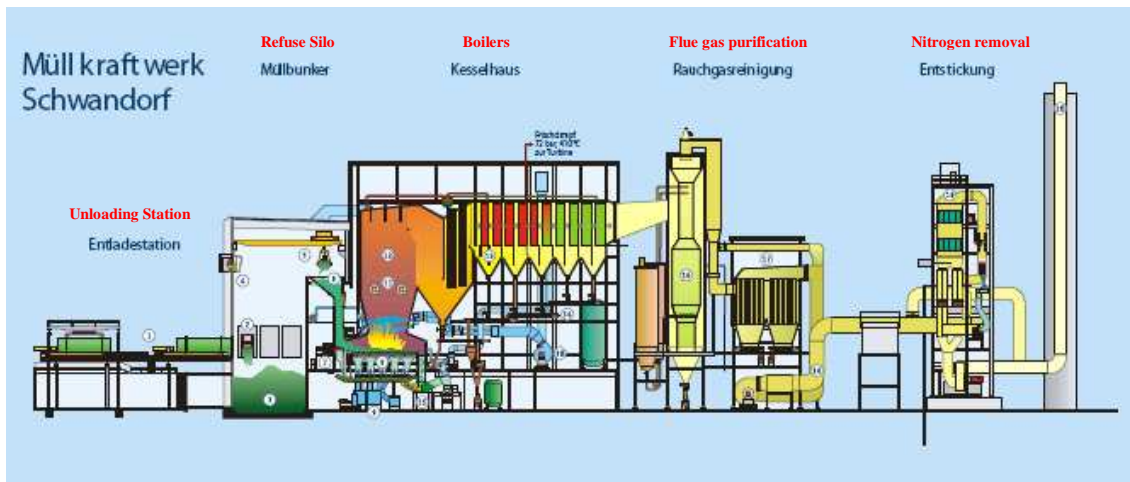
Figure 1: Cross-section of WTE plant in Schwandorf

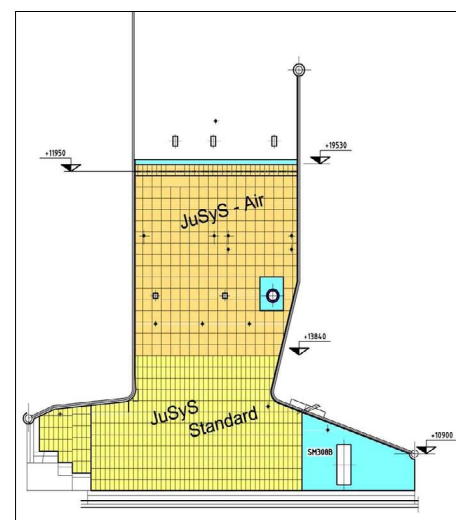
Figure 2: Refractory design with JuSyS tube wall tile systems in the combustion chamber and 1st pass

In 1999, the next development stage was reached in that the rear-ventilated **JuSyS®Air** tile system was installed in the upper area of the incineration chamber. Here, too, nitride-bonded SiC tiles were utilized which were inserted or rather hung in heat-resistant metallic anchoring components (no tension). Consequently, these tiles are held on the tube wall.

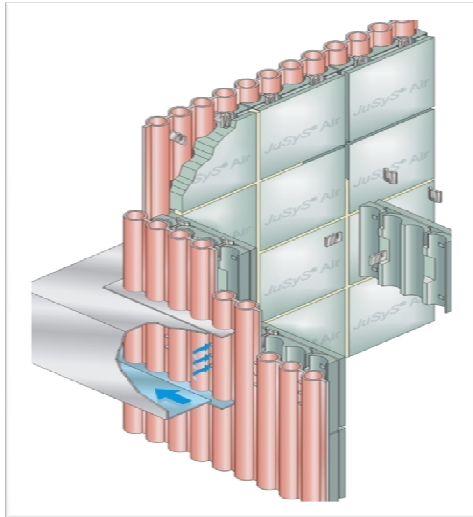
Figure 3: Rear-ventilated tile system *JuSyS*[®] Air

As illustrated in Figure 3, in the incineration chamber of the refuse boiler a refractory tube wall tile is connected by way of a special anchoring system to the boiler wall. Consequently, the tube wall tile hangs in a defined distance as protective layer in front of the boiler wall. This generates a defined gap between boiler wall and tube tile which is supplied with blocking air by an air distribution system. The air pressure of the blocking air in the gap is controlled in such a way that it is higher than the air pressure in the incineration chamber. This generates kind of an air haze which prevents the corrosive gases out of the flue gas from entering the air gap and causing corrosion damage on the boiler wall.

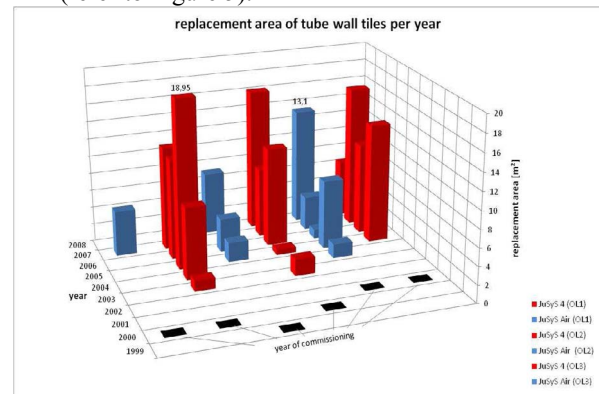
Figure 4: Tube wall tile replacement per year

Based on the evaluations in Figure 4 one can clearly see that the first tile areas did not have to be replaced until at least three years had passed. Consequently, at the Schwandorf WTE plant the refractory lining enabled operation times that were not even conceivable with the refractory linings out of refractory patching mixes used up to that date. Furthermore, it is noticed that the replacement of rear-ventilated plates (blue beams) is noticeably less than that of the glued tile systems (red beams) despite the total refractory lining surface for the rear-ventilated system being significantly larger in all 3 incineration lines. Overall, no more than 19m²/a had to be replaced with the glued system and 13m²/a with the rear-ventilated system. The superb performance of the refractory lining is really in the spotlight if making a comparison between the combined tile lining (glued and rear-ventilated) and the original lining out of SiC patching mix (refer to Figure 5).

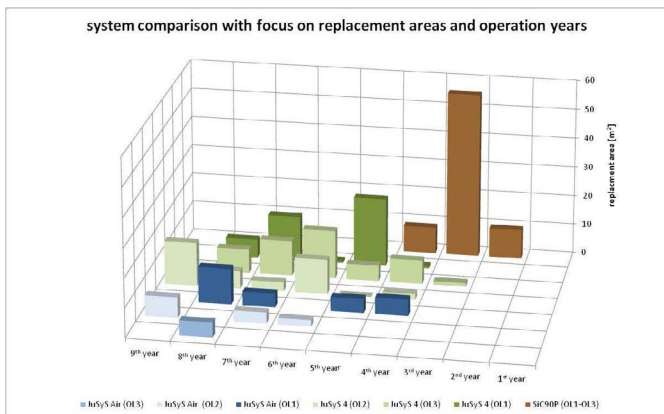
Figure 5: System Comparison

It can be seen that with the SiC mix lining the first lining areas already had to be repaired during the second year of operation and that during the third operation year it became necessary to make repairs in over 25 % of the total area. In addition to the damage to the refractory lining there was also major corrosion on the boiler wall of up to 3 mm in some spots (compare Figure 16). As already mentioned above, this effected the switch of systems used for the refractory lining. Due to this switch a significant replacement of the glued tiles was not required until approximately 5 years had past by. Replacements for the rear-ventilated system were not required until 6 to 7 years later. After applying the new lining system it was practically possible to eliminate corrosion on the boiler walls. Corrosion is now only a few micrometers (compare Figure 15).

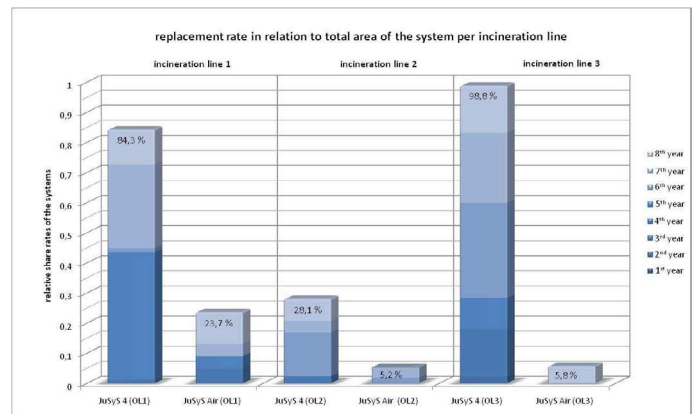
Figure 6: Replacement rates of the tiles systems

All plant operators are specifically interested in the replacement rates of systems. For this reason the relative replacement rates, based on the total system area, were recorded and documented over a period of 8 operation years. It was seen that during this entire period the glued tiles in incineration lines 1 and 3 had to almost be completely replaced. For incineration line 2 it became necessary to replace approximately 40 %. The replacement rates for the rear-ventilated plates are extremely low. Nobody would have guessed this at the start of service of the rear-ventilated system. After 8 years of operation less than 10 % of the total area of the system had to be replaced in the incineration lines 2 and 3. However, in incineration line 1 there are higher replacement rates. These increased rates are due to damages to the upper tile rows having occurred in the years 2004 and 2005 because the sealing by the SiC mix was not completely ensured in that area. Consequently, the upper tile rows had to be replaced due to corrosion on the holding components. If one disregards this replacement work, incineration line 1 would also have a replacement rate of under 10 % of the total area of the system. In summary, the service life or performance, respectively, of the rear-ventilated tile system is at a remarkable and record-breaking level in all 3 incineration lines.

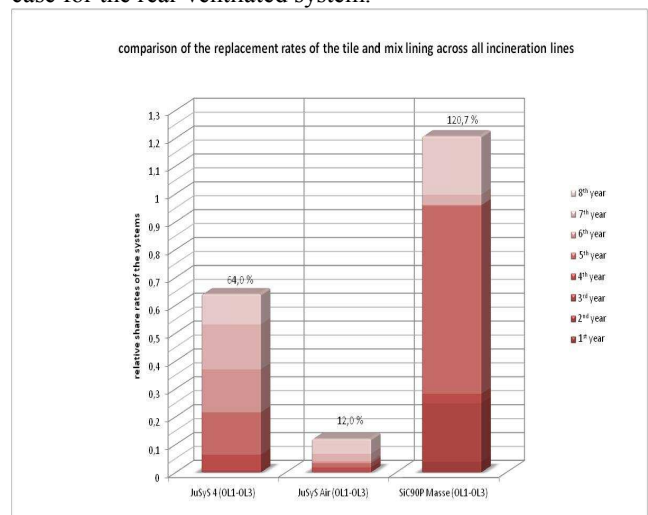
Figure 7: Replacement rates of the various lining systems

The varying service life performance of the three lining systems (glued tiles, rear-ventilated tiles, patching mixes) is illustrated well in Figure 7. For example, one can see that the glued tile system, when compared with the original lining out SiC 90 patching mix, has an almost 50 % lower replacement rate if the lining out of refractory mix would have accomplished a fictive operation period of 8 years. Since the lining out of refractory mix was replaced with tiles after 4 years, the replacement rates were projected for 8 years. This generated the calculated replacement rates to be 120.7 % for the system with refractory patching mixes.

Consequently, in comparison with the SiC patching mix lining and based on the specific total area of the system, glued tiles had a twice as long service life and rear-ventilated tiles up to a tenfold as long service life (refer to Figure 7). Due to this precise evaluation work at the Schwandorf WTE plant, the previously made service life projections or assumptions, respectively, were significantly surpassed. This is especially the case for the rear-ventilated system.

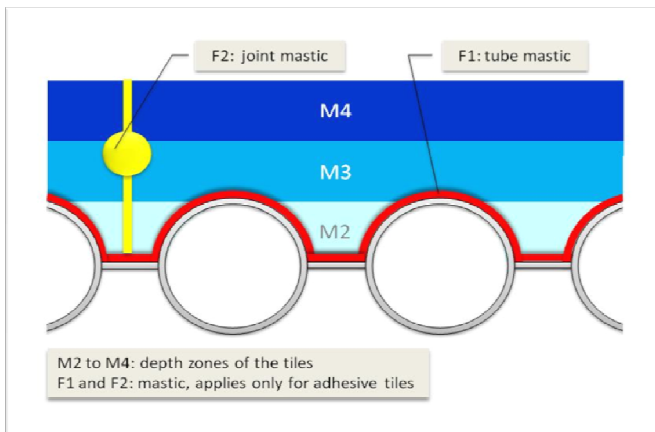
Figure 8: Illustration of the areas where the sample tiles were taken

In addition to the documentation on the replaced areas in all 3 incineration lines, chemical examinations were also conducted on the used shaped tiles for tubes in incineration line 2. Samples were taken from different height levels in the plant and based on different operation times. Next the X-ray fluorescence analysis process was applied to quantify the various substances causing stress. The analyses were conducted in various depth zones of the tile to be able to make a statement on penetration depth and varying degree of enrichment of the pollutants. With the glued tile system the tube wall tile is positioned in a refractory SiC mortar. Consequently, the refractory mortar at the tube wall and between the tiles was examined chemically (compare Figure 8). This chemical examination focused on the corrosion-relevant substances such as chlorine, sulfur and typical alkali and heavy metal salts. These effect the high temperature chlorine corrosion and salt melting corrosion.

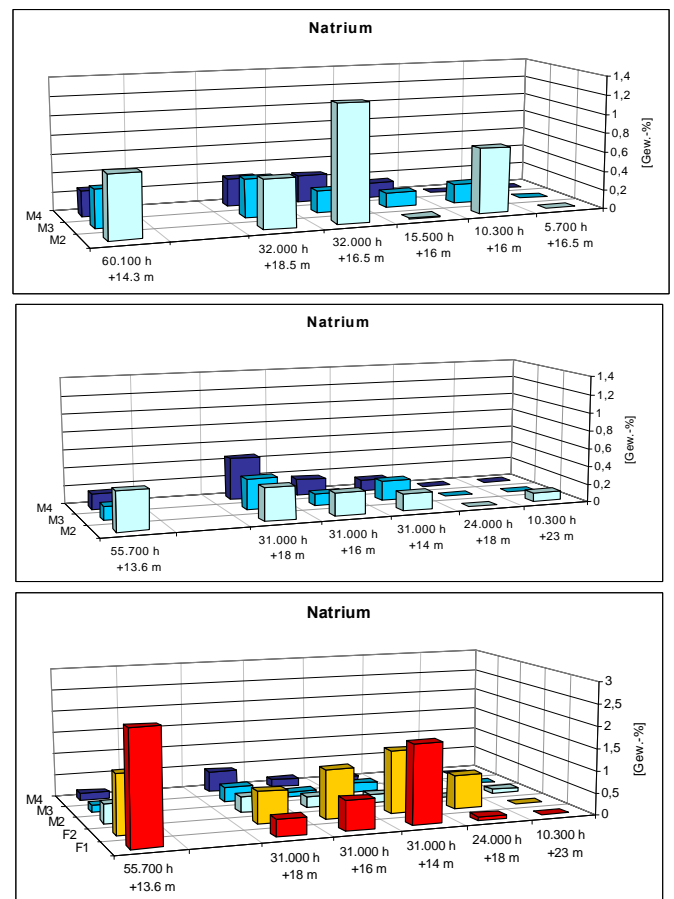
Figure 11: Sodium concentration in rear-ventilated tile, glued tile and glued tile plus mortar

When taking a look at other alkali metals having an influence on corrosion, such as sodium and potassium, one generally sees an increased concentration in the M2 layer with the rear-ventilated system and in the mortar area F1 with the glued system. Here, too, the functioning of the rear ventilation can be clearly seen. The rear ventilation gap interrupts the diffusion of the corrosion elements to the tube wall. In addition, the coldest area of the tile is located in the M2 layer. Consequently, this leads to condensation of alkali salts. These have a hard time reaching the tube wall because of purging and the distance between the system components. In contrast to this, there is a visible increased concentration of the corrosive elements in the mortar layer of the glued tile system. The corrosive elements can reach the tube wall by way of diffusion processes. In the end, corrosion is the result.

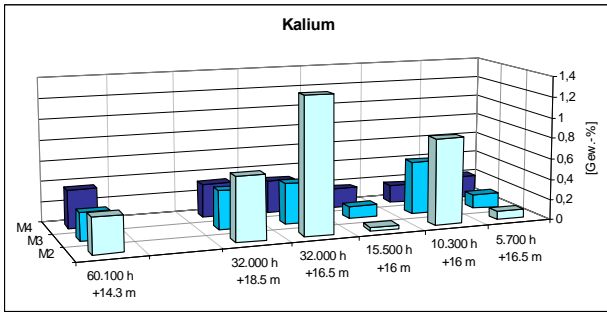
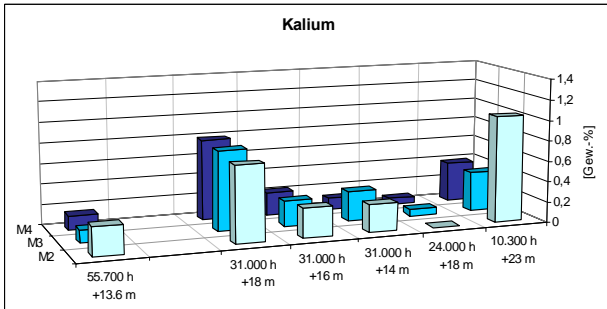
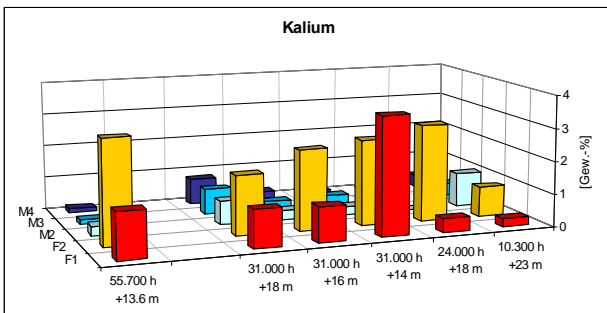
Figure 12: Potassium concentration in rear-ventilated tile, glued tile and glued tile plus mortar

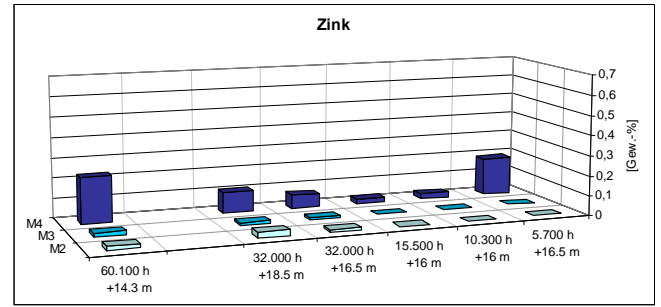
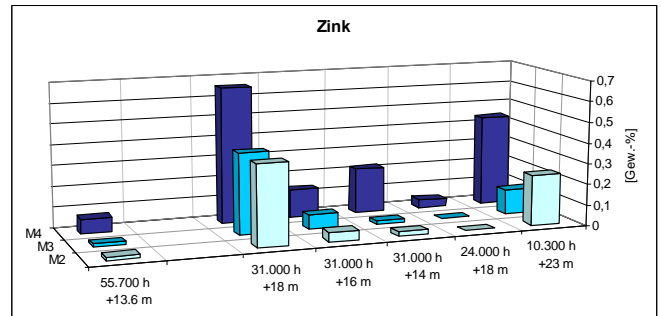
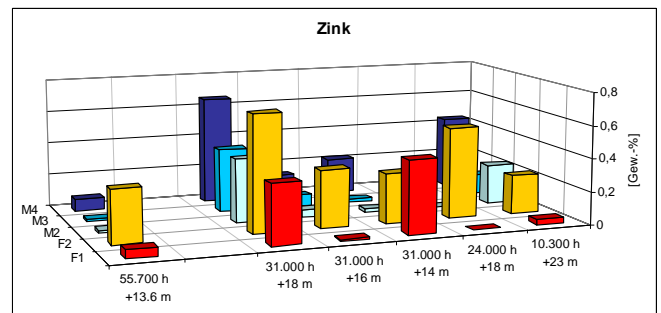
Figure 13: Zinc concentration in rear-ventilated tile, glued tile and glued tile plus mortar

The positive properties of the rear-ventilated tile become very obvious when taking a look at the results of the analysis of the stress caused by zinc and lead (Figures 13 and 14). These metals, which as chlorine salts have relatively low melting points (approximately 200-300 °C), get very close to the tube wall and can, consequently, release chlorine for effecting corrosion on the tube wall. However, the examination showed that for the rear-ventilated system, in comparison with the glued version, these metals are practically not detectable. With the glued tile system there is a noticeable increase of the metals zinc and lead, specifically in the mortar area on the tube. In contrast to the alkali salts, with their generally higher melting points (approximately 350-450 °C), these heavy metal salts condensate comparatively close to the cooled tube wall. With the rear-ventilated tile this temperature range of condensation is, however, first possible in the blocking air gap. Consequently, a coating (deposit) is not possible at this location due to the supply of blocking air. This in turn underscores the functionality of the system in regard to providing good protection against corrosion.

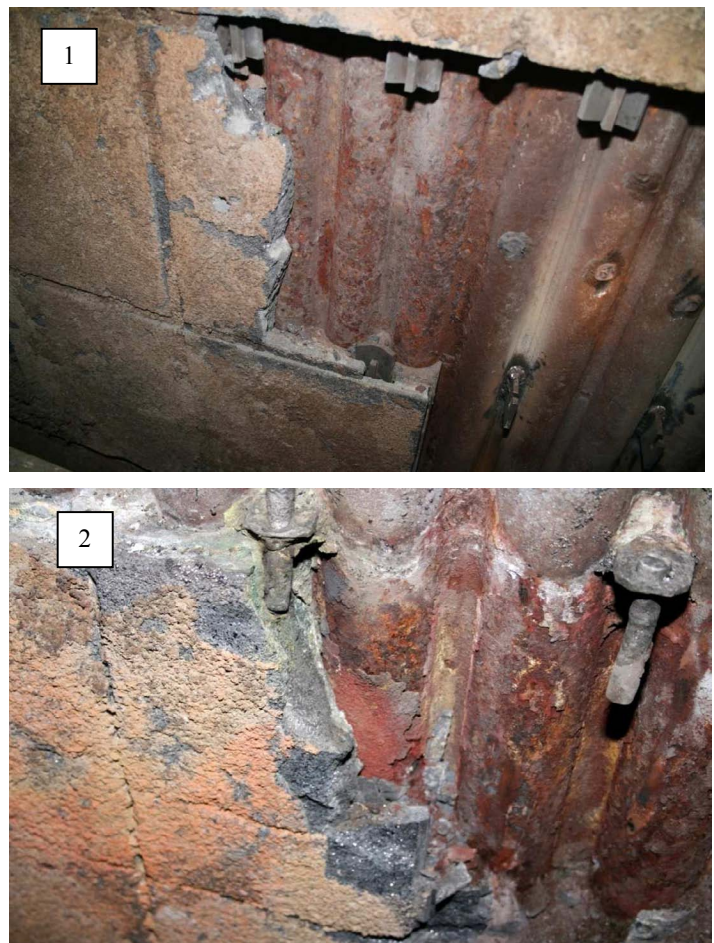
Figure 15: Breakout area of *JuSyS®Air* (1) and *JuSyS®Standard* (2)

One can also visually see the difference between both systems (rear-ventilated and glued). As part of the continuous plant inspections, samples were taken from both systems in the area of the tile sections that had to be replaced. These samples were taken in June 2008. In Figure 15 the breakout area of a rear-ventilated tile and glued tile is illustrated. It can be clearly seen that thicker salt coatings (deposits) and corrosion layers have formed in the area of the glued tile than is the case in the area of the rear-ventilated tile. The tube wall behind the rear-ventilated tile does not have any visible salt coatings (deposits) and only small corrosion layers. Furthermore, the holding components of the tiles look almost as if they were new and hardly show any signs of corrosion attack. In contrast, in the glued tile area there are clearly visible signs of wear on the holding component as result of corrosion. Nonetheless, these components are amazingly still in a very good condition after an operation time of 60,100 hours. In contrast, Figure 16 shows dramatic wear and extreme corrosion. Here you see a studded tube wall with a refractory lining out of SiC mixes. This lining became defective during the operation of the plant. Such corrosion phenomena during an operation period of 4 years were the reasons or rather cause that during the first operation years of the Schwandorf

WTE plant the partial boiler corrosion in that area was up to 3 mm.

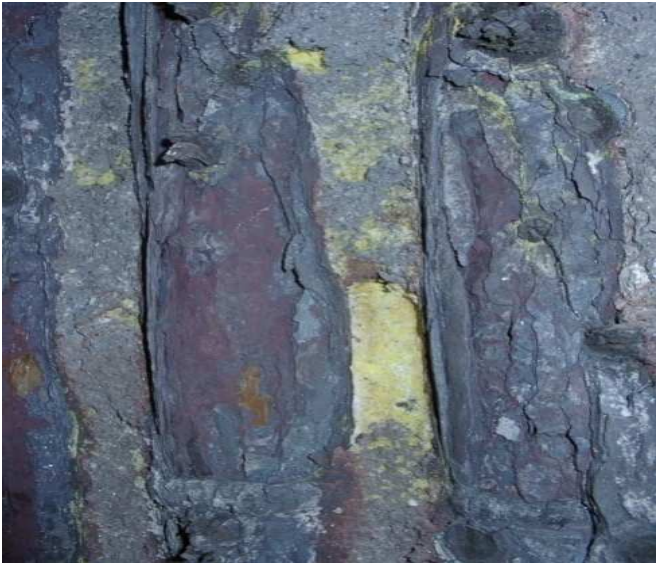
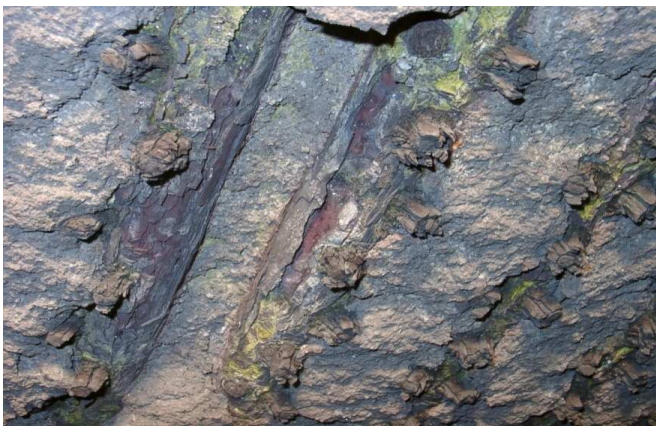
Figure 16: Tube wall with refractory lining out of SiC mixes after approx. 2 years of operation

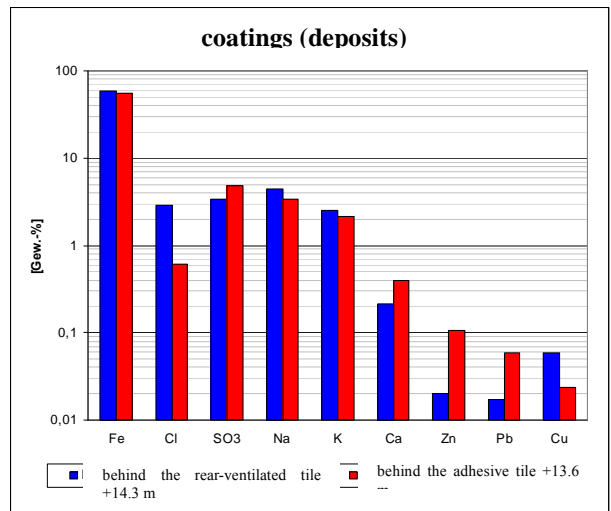
Figure 17: Comparison of the chemical composition of the coatings (deposits) behind the tiles

If one subjects the corrosion coatings (deposits) on the boiler wall to a chemical examination, one will see that, except for the heavy metals zinc and lead, there is no significant difference regarding the chemical composition between the glued and rear-ventilated tiles (compare Figure 17).

However, the share of alkali chlorides is somewhat higher with the rear-ventilated system. Generally the concentrations are at a very low level so that during the long operation of the systems there was no boiler tube wear worth mentioning since the first installation of both tile systems.

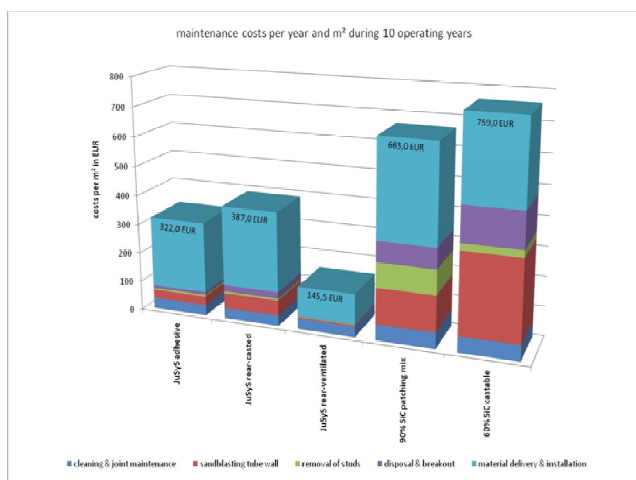
Figure 18: Maintenance costs for the various systems during 10 operation years

A calculation was performed with the assistance of a model boiler in order to demonstrate the efficiency of the rear-ventilated tile system. The maintenance costs for a period of 10 years were totaled and subsequently divided by the number of operation years and based on 1m² boiler area. For the model boiler with 300 m² lining there was a repair time of 30 days in 10 years. This calculation is confirmed by the documentation collected in Schwandorf. In contrast to this, it must be considered approx. 200 days for installation of replacement refractory materials, if the lining consists of refractory castables or SiC mix. Without commenting this immense loss of production, the consideration of maintenance costs for the various systems alone demonstrates the superiority of the rear-ventilated tile system (refer to Figure 18).

Furthermore, the maintenance costs in Western Europe for the rear-ventilated system are under Euro 150.00/m² of lined boiler area in 10 years. These costs can be up to or even over Euro 750.00/m² boiler area if the refractory lining consists of 60 % SiC refractory castables.
