NAWTEC18-35, \$

NEW GENERATION OF TUBE SURFACE TREATMENTS HELP IMPROVE EFW BOILER RELIABILITY

Greg Epelbaum, Principal Boiler Engineer, Covanta Energy
Eric Hanson, Boiler Reliability Director, Covanta Energy
Dr. Michael Seitz, AmStar Surface Technology

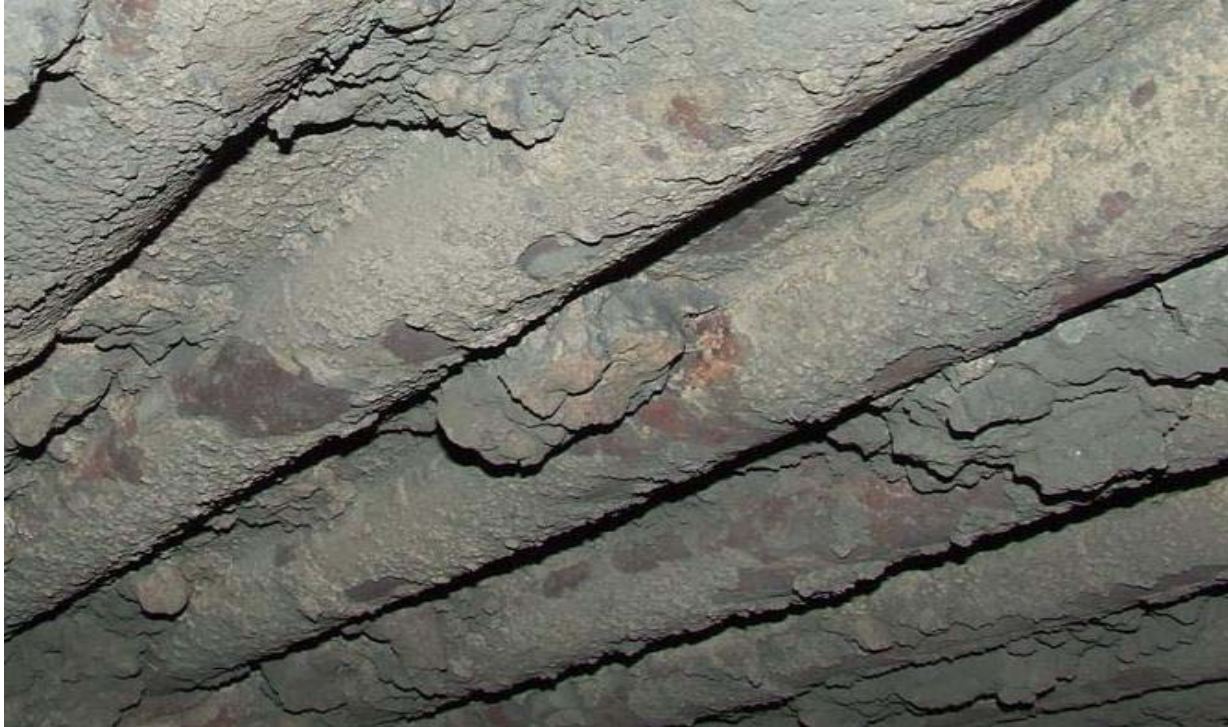
Figure 1. Roof waterwall area covered by slag before it was removed prior to AmStar’s cladding activities.

The cladding was performed during the scheduled boiler outage. Both areas were covered by slag, especially hard (ceramic like) over 2" thick slag was found on the roof tubes (see Figure 1). Covanta plant personnel removed the slag prior to the commencement of AmStar's cladding activities.

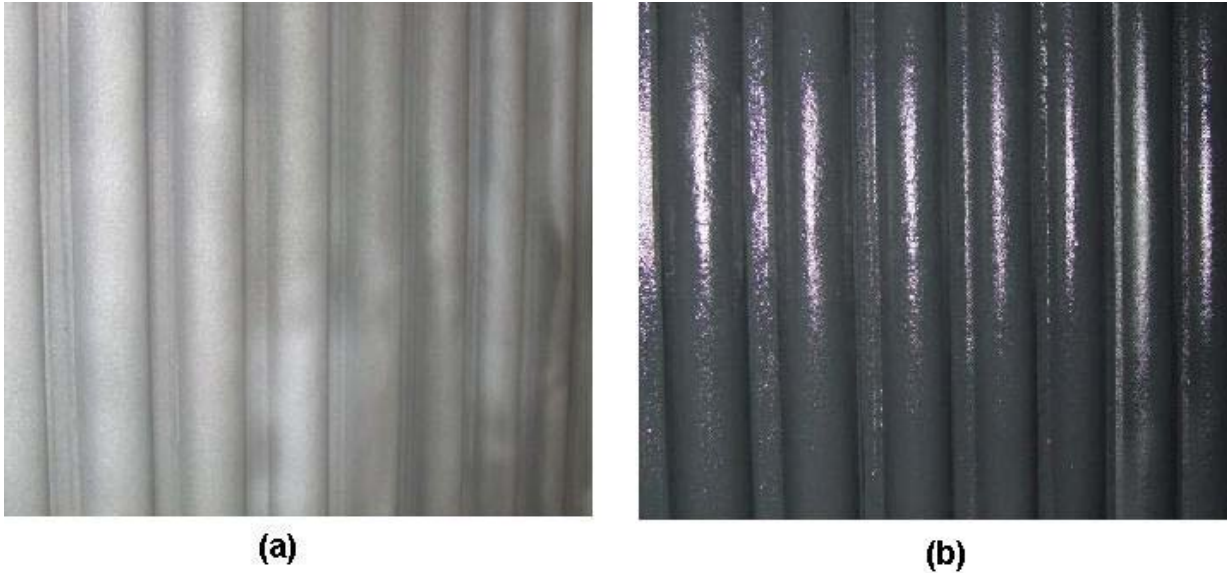
Figure 2. The cladding as sprayed (a), and after application of the surface passivator (b).

Once the application was complete, the entire cladded area was coated with AmStar's HCA – 40H surface passivator (see Figure 2) which cures at high temperature upon boiler startup. The passivator serves to smooth out the surface of the cladding and acts as a de-slugging agent.

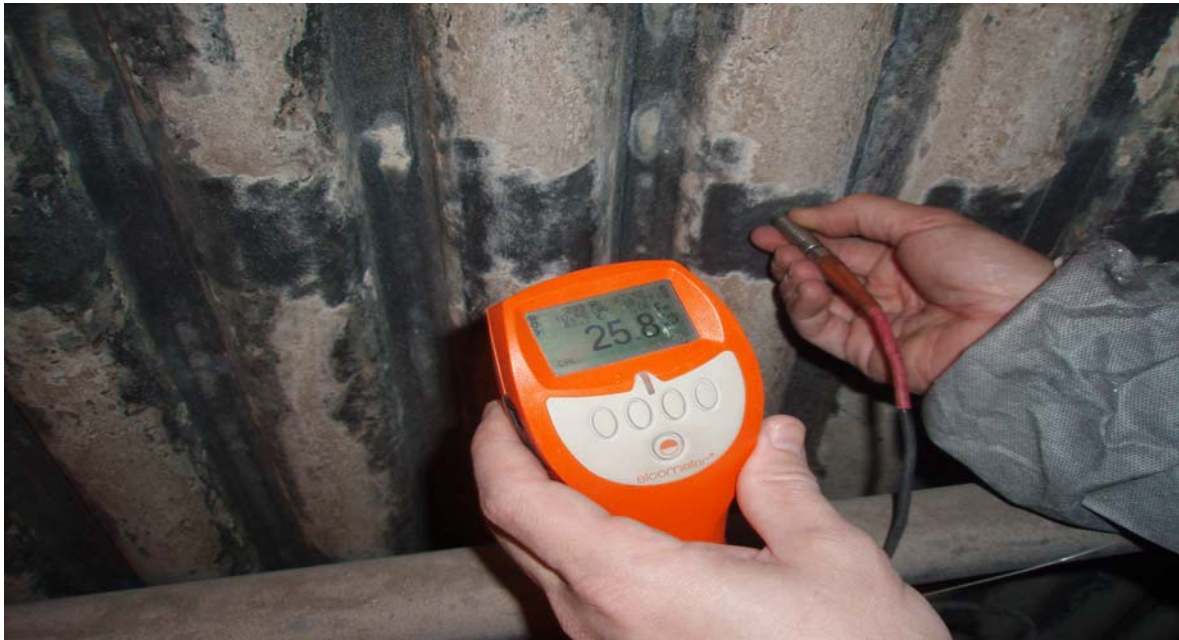
Figure 3: AmStar 888® cladding inspection 13 months after application.

The latest inspection of both areas was performed in February 2009 (13 months after cladding). The cladding was visually inspected and thickness data for both areas were recorded using the same coating thickness gauge (see Figure 3). No cladding defects were observed, passivator was found completely intact, and no loss of coating thickness was detected.

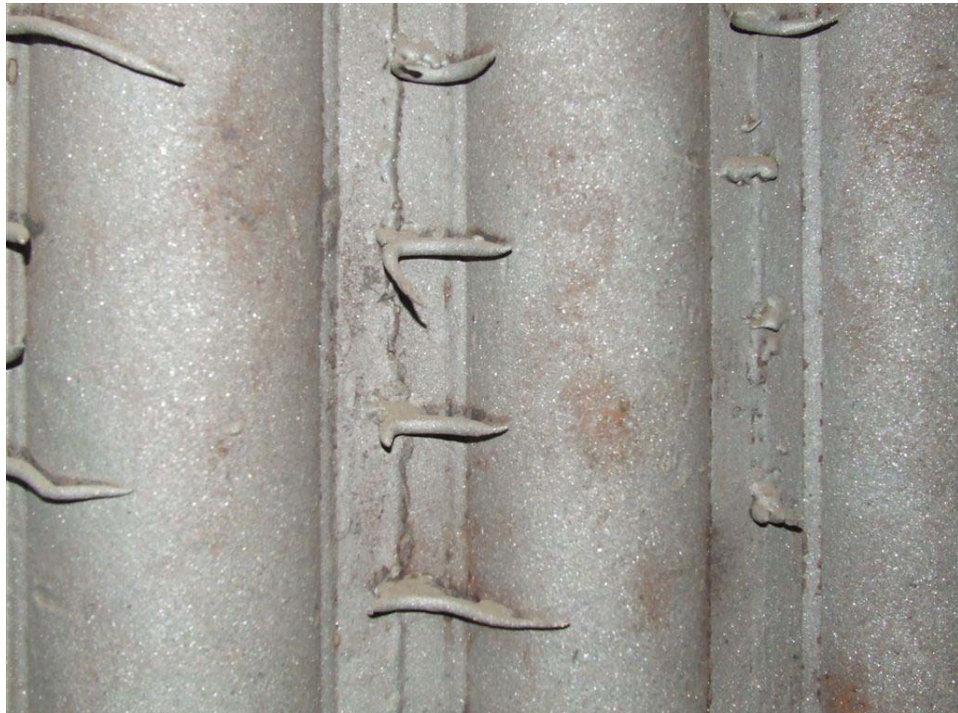
Figure 4. Refractory anchors in area to be cladded

1. The presence of bent wire refractory anchors in the area to be clad (Figure 4),
2. The presence of refractory studs in the area to be clad (Figure 5),
3. Large areas of old refractory still present in the area to be clad (Figure 6).

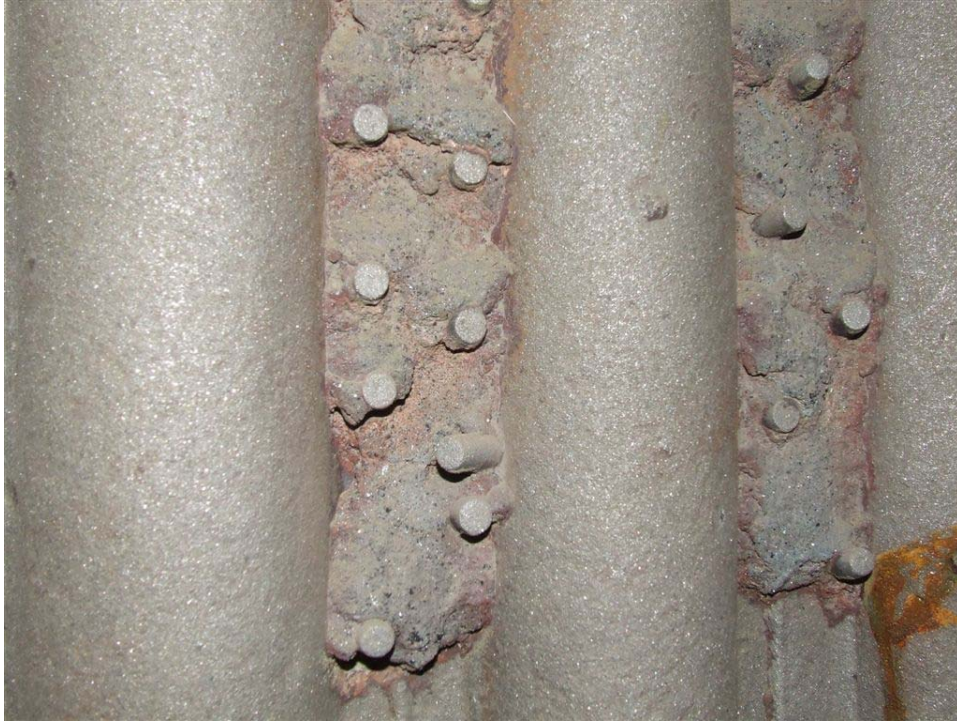
Figure 5. Studs and refractory in area to be cladded

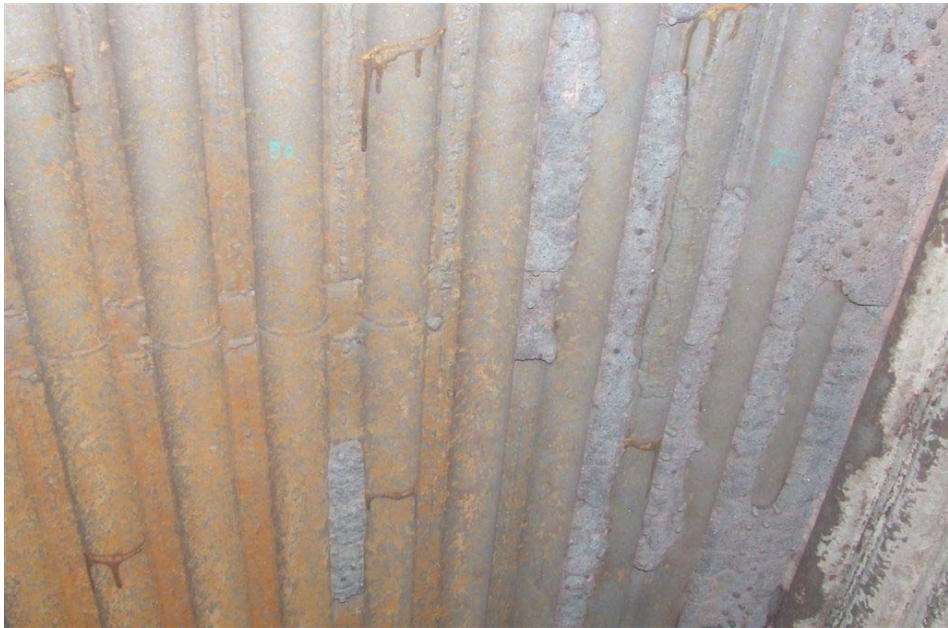
Figure 6. Large area with refractory obstruction in area to be cladded

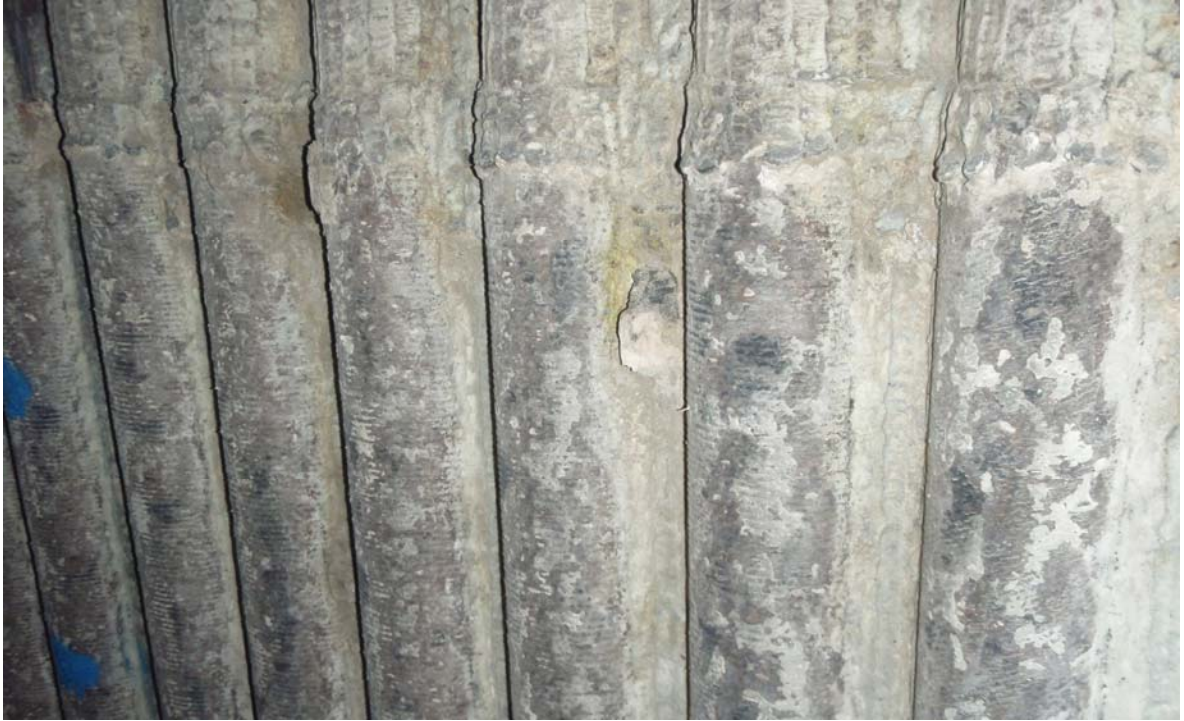
Figure 7. Visual inspection illustrating that no thinning or delamination occurred where the cladding was applied over old weld overlay.

The coating was inspected approximately 12 months following application. The carbon steel sections appeared in perfect condition, with no signs of thinning or spalling. The performance over the weld overlay was consistent with performance on carbon steel (Figure 7). Given the practical cladding difficulties, this test showed the effectiveness of the

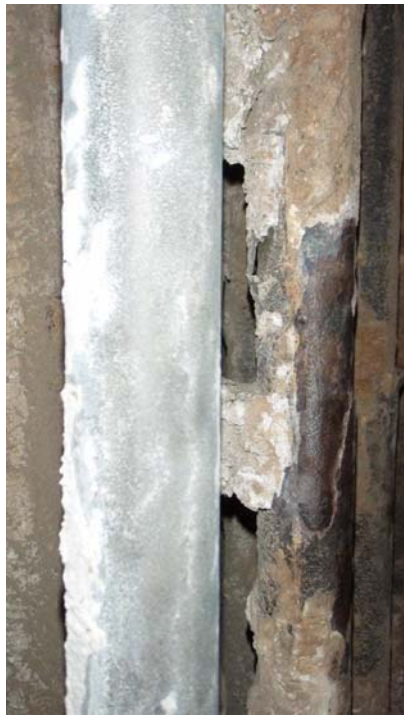
Figure 8. AmStar 888® cladding on left tube after 3.5 years of operation in comparison to an unprotected adjacent tube being in service for only 18 months

The Amstar test tubes installed in both Finishing and Intermediate superheaters showed no visible signs of failure or measured thickness loss. Figure 8 shows the Finishing superheater trial tube, which has been operating in the harsher corrosive environments than the Intermediate superheater tube with the calculated metal temperature of approximately 750°F and the flue gas temperature in a range of 1200 – 1500°F. This has been an encouraging performance record of the AmStar 888® cladding technology for the superheater applications.

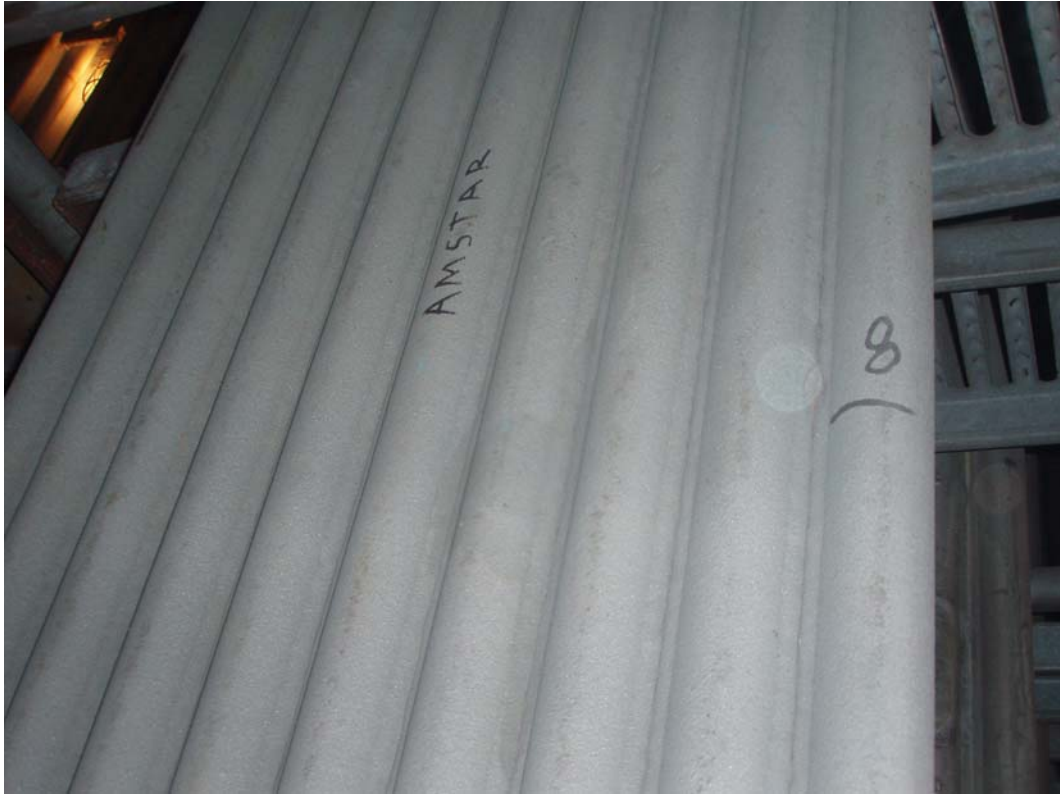
Figure 9. AmStar 888® cladding 39 ft Panel 3-4 installed in Pass 3 without passivator

AmStar 888® cladding material was applied in March 2008 for this most challenging upper part (39' from Pass 2 Roof) of one panel, including the lead and trail tubes. This application was done in the AmStar shop. The coated panel was delivered on site and installed with all other finishing superheater panels (see Figure 9). After this panel was installed, the AmStar crew came to the plant at the end of the outage and applied HCA – 40H surface passivator in 3 hours.

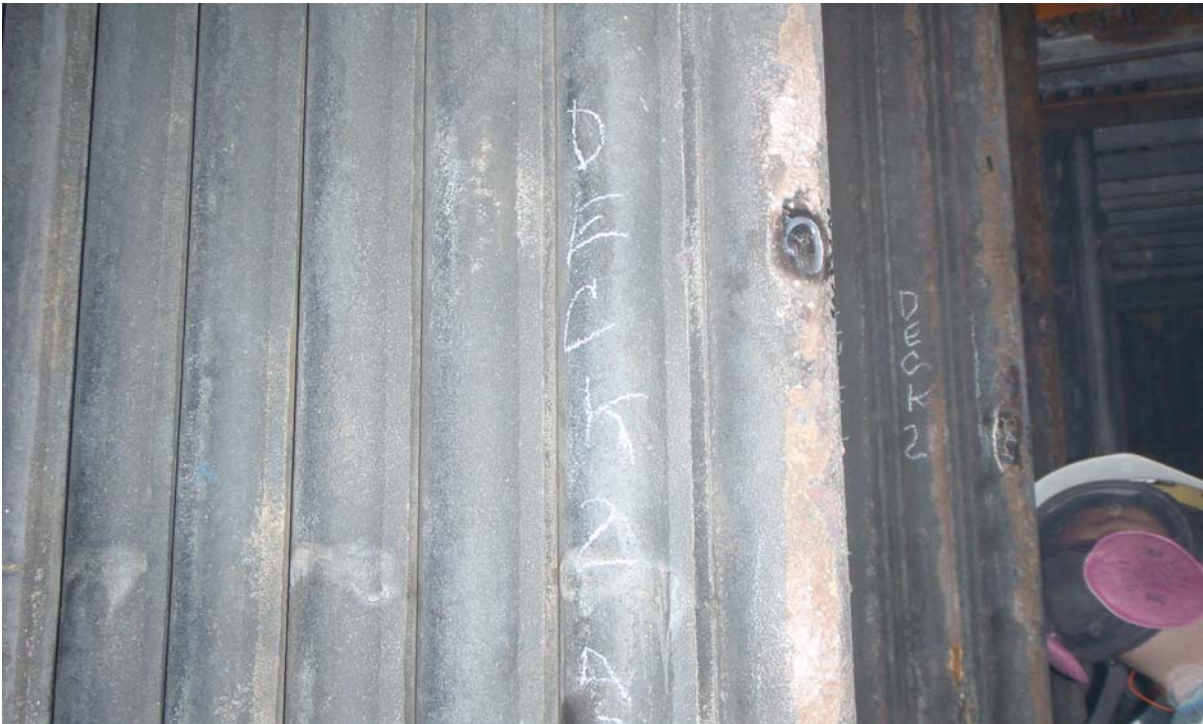
Figure 10. AmStar Panel 3-4 (left) and Coating Y Panel 3-5 (right) after one year of operation.

revealed some deterioration of the coating at the lead tube upper 12 feet. Cladding X looked marginally better than AmStar, and Coating Y looked worse than the two other trial panels. But the middle 8 tubes of all three panels looked very impressive in comparison to the unprotected T22 tubes in the non-trial panels (see Figure 10 and 11). As some of the middle unprotected T22 tubes lost 120 – 130 mills of wall thickness, indicated by conducted UT readings, the body of adjacent surface treatment panels was still well protected by coating with no loss of the base metal underneath.

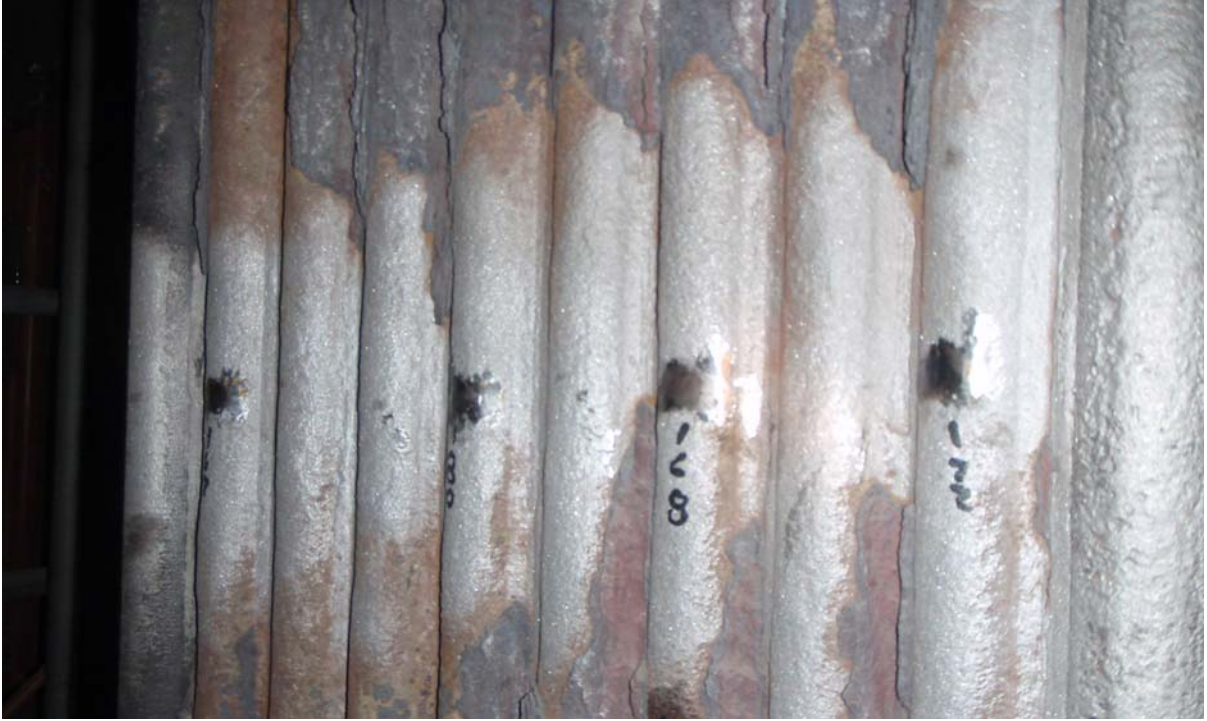
Figure 11. Panel 3-7 (one of five non-trials) with Inconel 625 weld overlay for the lead and trail tubes and 8 unprotected SA-213T22 tubes in between after one year of operation (with tube wall thickness readings).

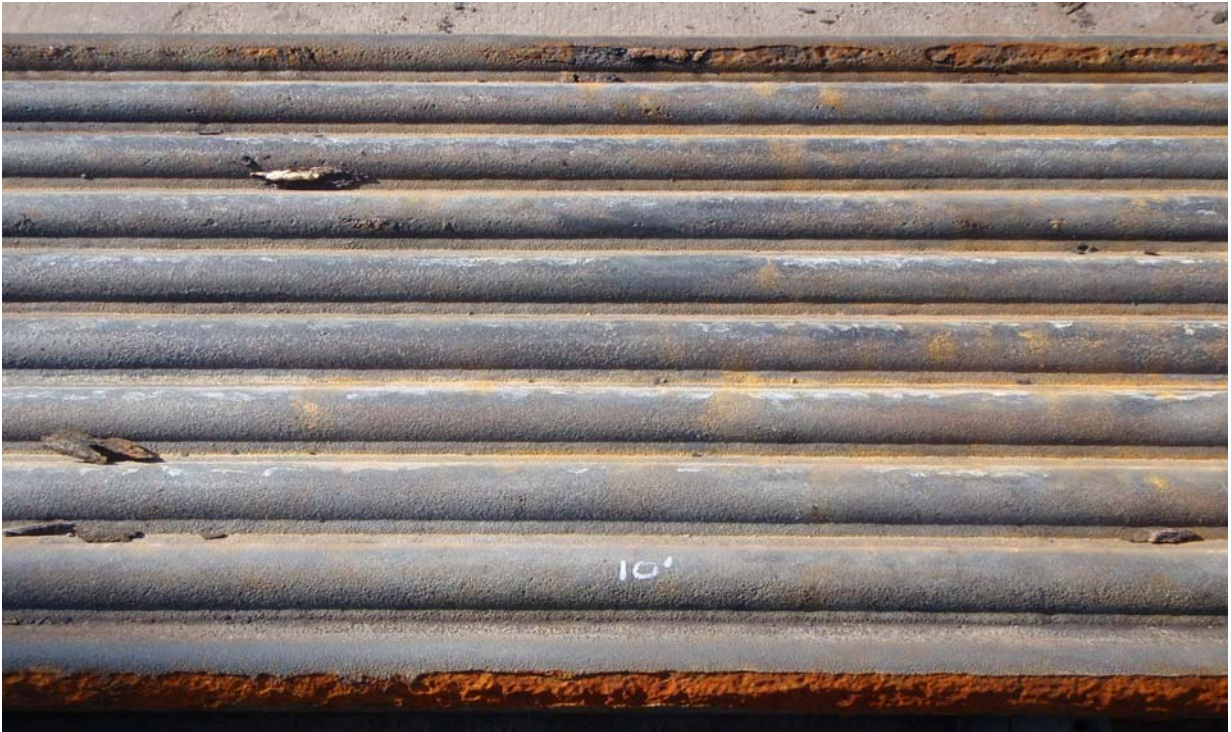
Figure 12. AmStar Panel 3-4 after 2 years of operation at top 10' from Roof (lead tube at the front).

The second inspection of the trial panels was performed in January 2010 (almost 2 years after installation). All Stage 3 finishing superheater panels were replaced according to the outage plan, and the trial panels were inspected outside the boiler. The results were consistent with the inspection after one year of operation. All three surface treatments revealed serious deterioration of the coating at the lead tube upper 20 feet and the trail upper 10 feet (see Figure 12). This time more pitting was found on the second tube and some delamination in a couple of areas of the top 20 feet. The middle 8 tubes still looked very good in comparison to unprotected T22 tubes in five other panels. Figure 13 shows the drastic difference between AmStar coated Panel 3-4 at 35' from the roof and its adjacent non-trial hybrid panel (with Inconel 625 weld overlay for the lead and trail tubes and 8 unprotected SA-213T22 tubes). In addition to visual inspection, the cladding thickness was measured by a coating thickness gauge, which revealed basically no thickness loss for these panels except the damaged areas on the upper lead and trail tubes and in a few defected areas of the middle tubes. The Essex trial results seemed to confirm a hypothesis of different corrosion mechanisms taking place on the surface of the lead and trail tube vs. middle tubes of the same panel. Predominant corrosion in the middle tubes looks like a combination of mechanisms 1, 2, and 3 (described in Introduction), as for the lead and trail tubes mechanism 4 (molten salts eutectics) kicks in and takes the lead in coating and base metal destruction. The lead and trail tubes are also more exposed to radiant heat, flue gas flow direction, and ash deposit morphology, which can highly influence corrosion rates at such metal and ash deposit temperatures [9]. The Essex trial shows the potential to extend the finishing superheater panel life if a further solution for the lead and trail tubes can be found.

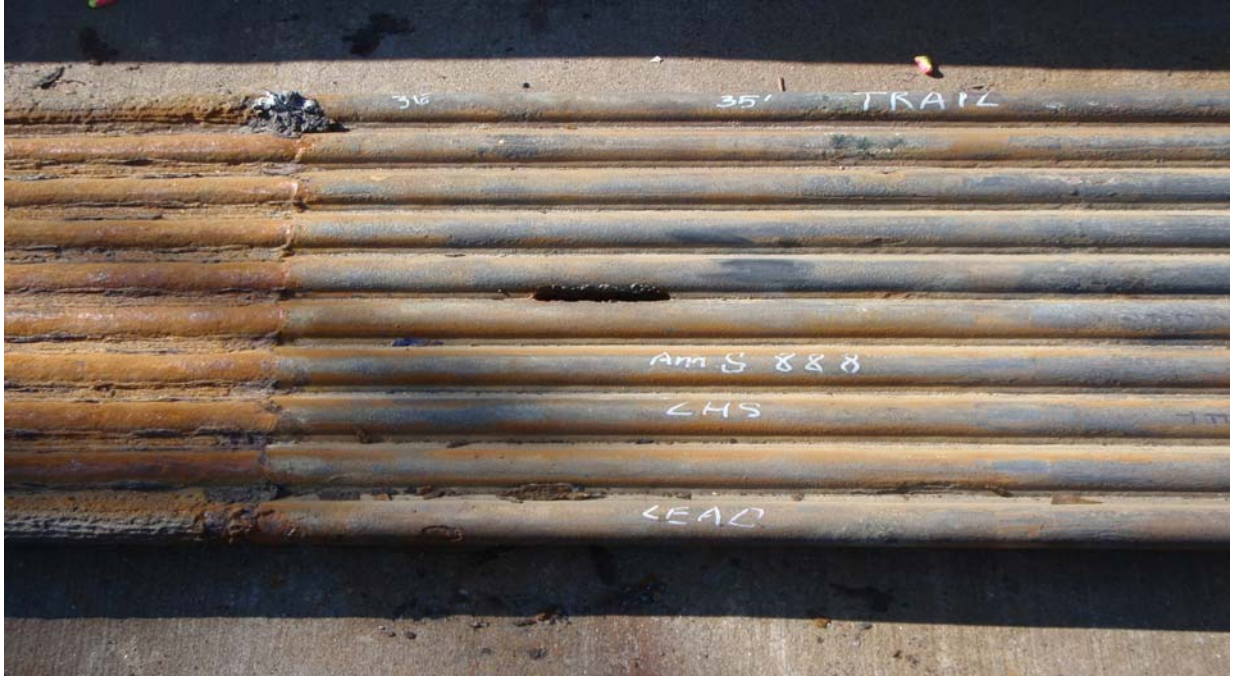
Figure 13. AmStar Panel 3-4 after 2 years of operation at 35' from Roof welded to non-trial panel with Inconel 625 weld overlay for the lead and trail tubes and 8 unprotected SA-213T22 tubes.
