# **Extending the Service Life of Furnace Wall Tubes Using Thermal Sprayed Coatings**

***Y. Matsubara,  
Y. Sochi, M .Tanabe, A. Takeya,  
Surface Treatment Division, Dai-Ichi High  
Frequency Co. Ltd, Kawasaki, Japan***

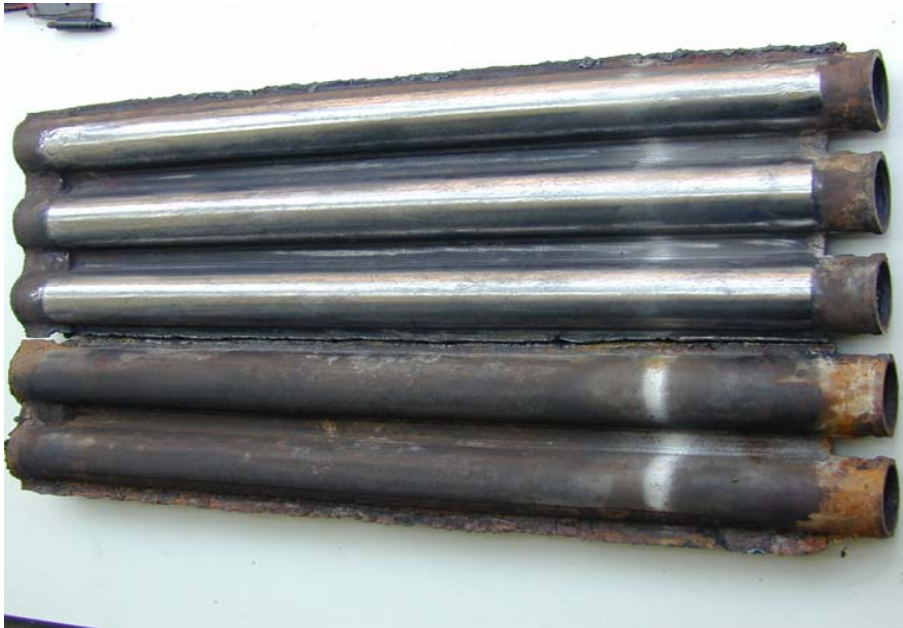
## Figure 3: Appearance of Furnace Wall Tubes after Service

**Treated Tubes**

**Untreated Tubes**

**Table 4: Thickness of Wall Tubes after 24 Months**

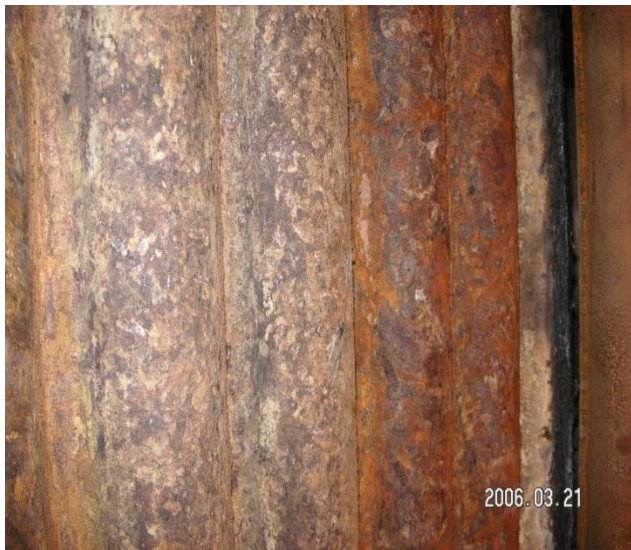
**Figure 6b:**  
**Analysis Samples of Oxide on Wall Tube**

**Oxidized and Corroded  
Wall Tube**

**Scale Outer  
Surface**

**Scale Inner  
Surface**

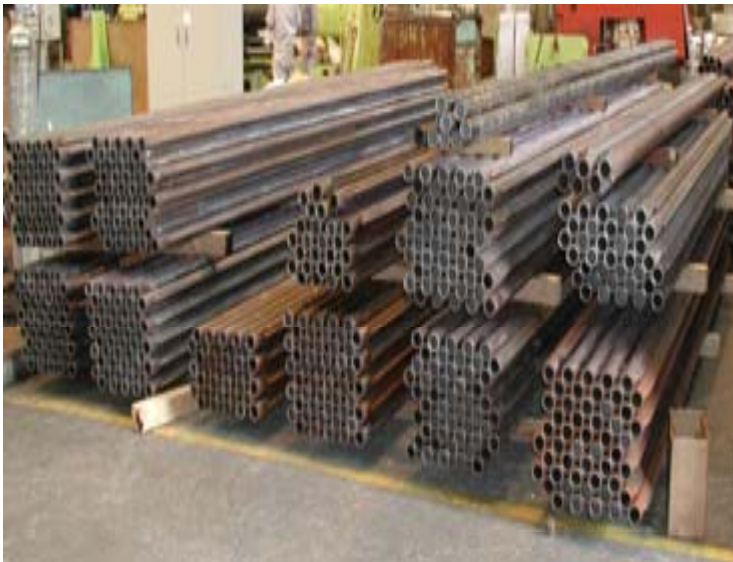
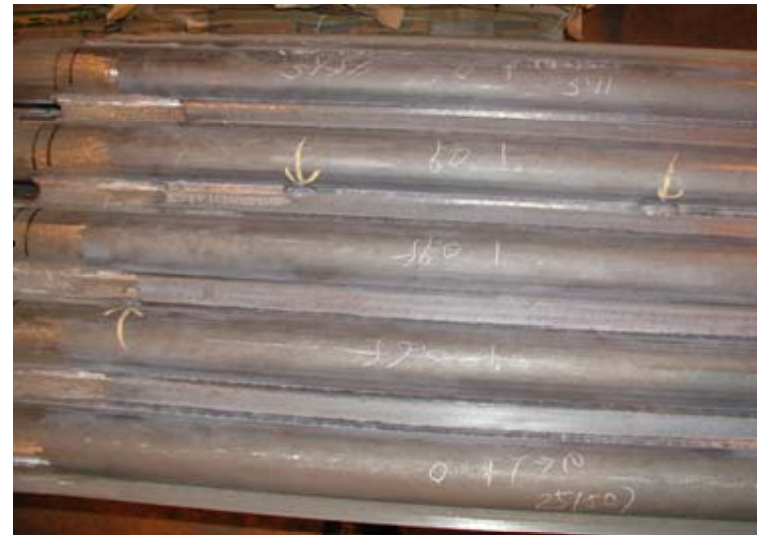
## Figure11a: Appearance of Furnace Wall Tubes Before Treatment

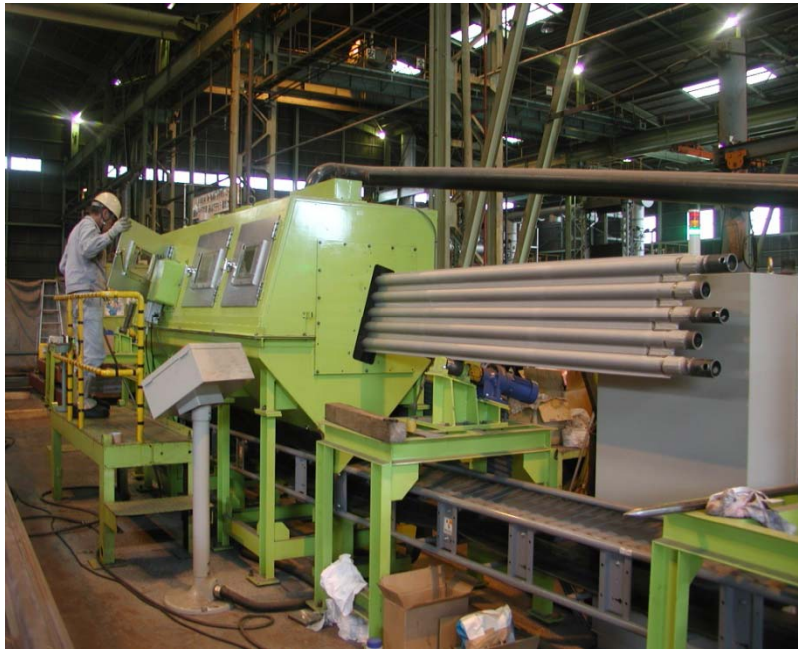
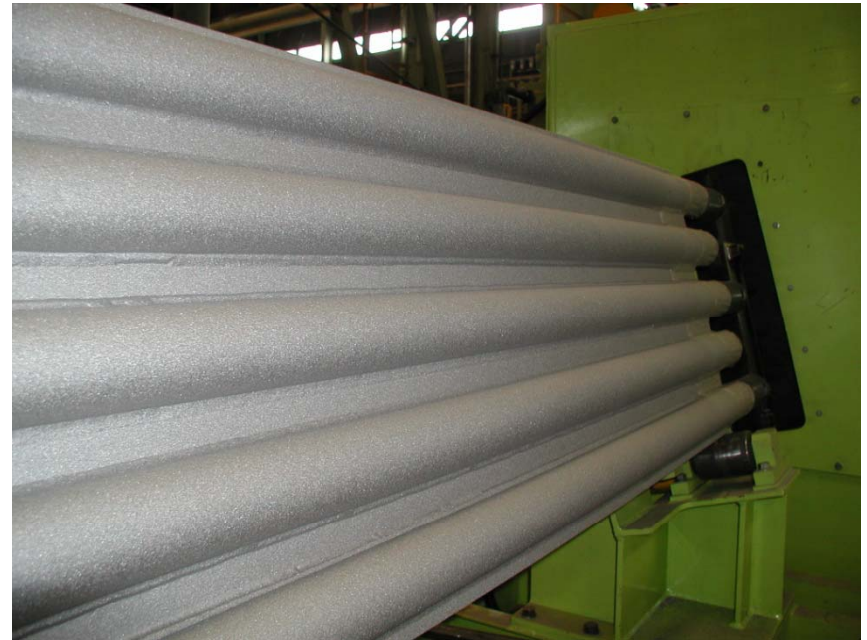
**Figure 11b: Appearance of Blasting  
Surface Roughness  $Ra \geq 15\mu m$**

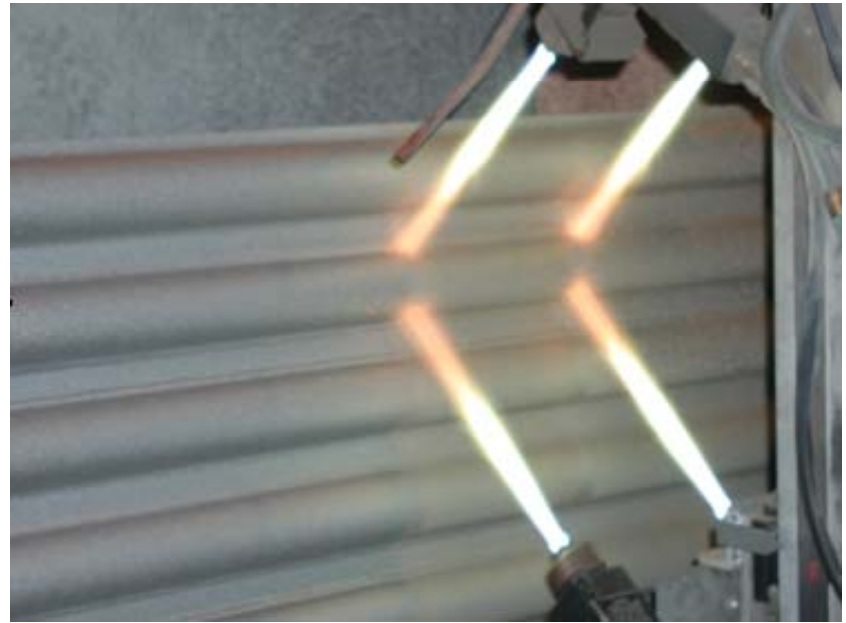
# Figure11c: Flame Spraying

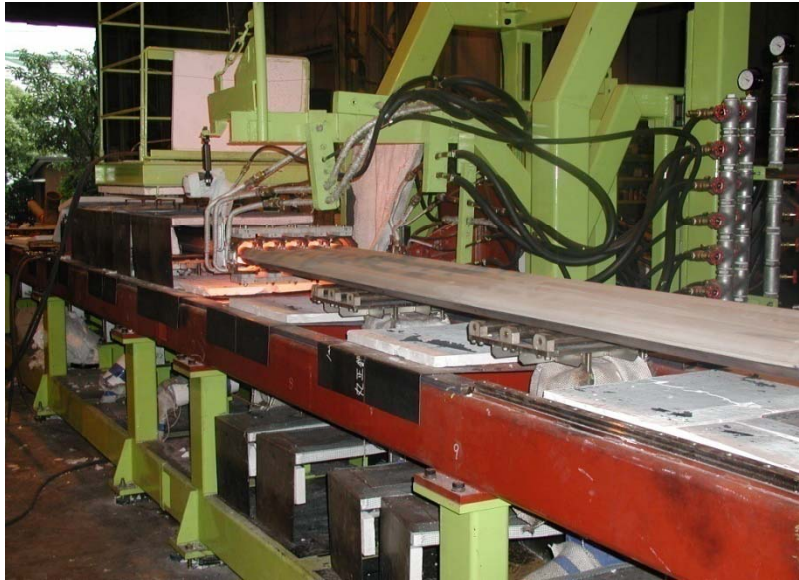
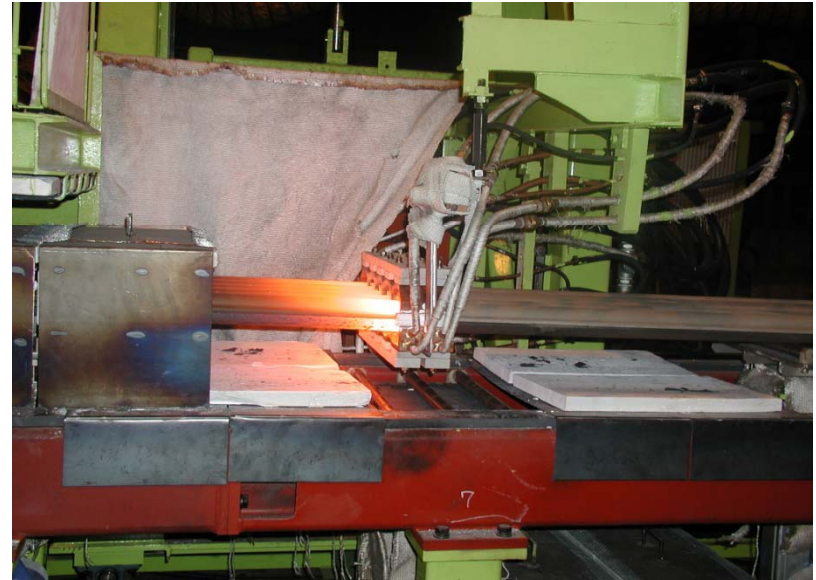
## Figure11d: Induction Fusing

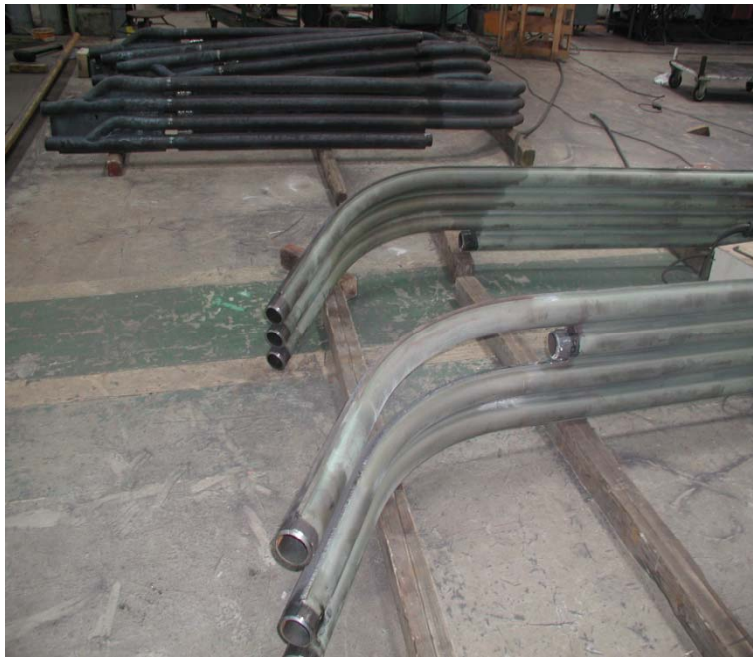
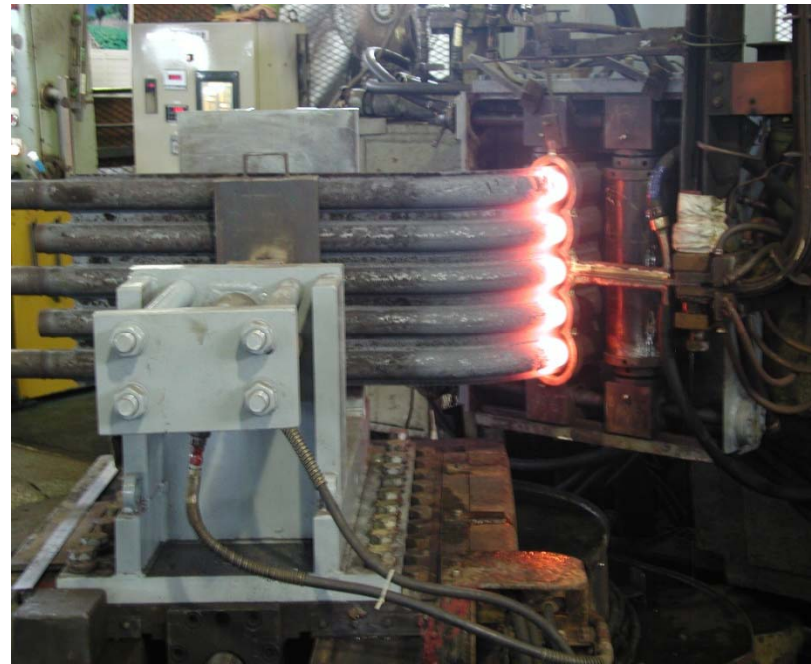
## **Figure 11e: Induction Bending of Units for Roof Section**

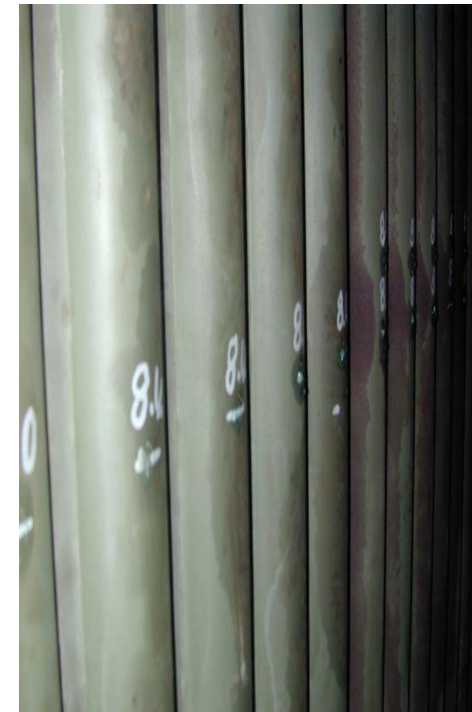
**Figure 12: Position of 11 Units in Front Furnace Wall**

**Treated Units**

**Table 6: Thickness of Units after 2 and 3  
Years (mm)**

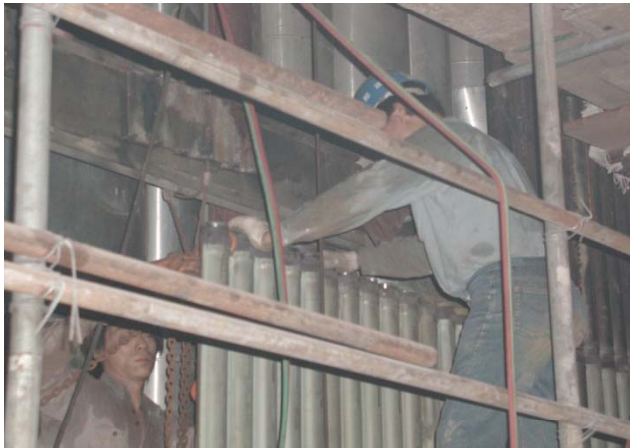
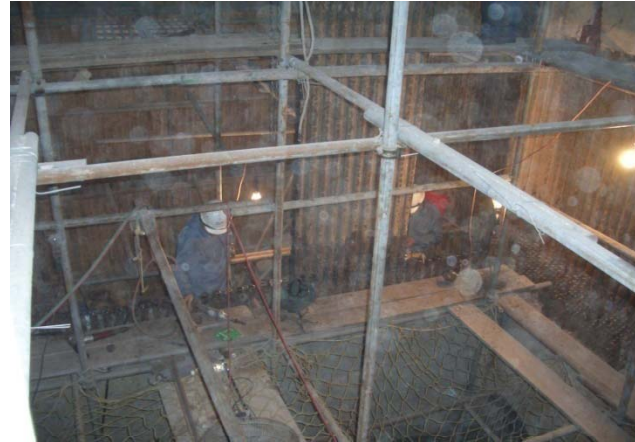
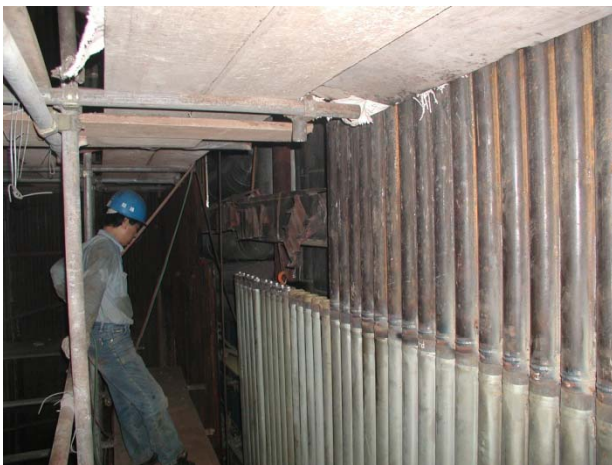
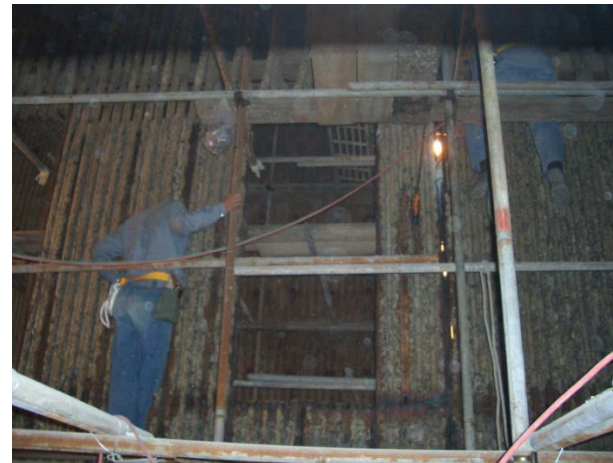
**Figure15a:**  
**Appearance of Waste Incineration Furnace**  
**( 5m x 7m in Width and 35m in Height )**

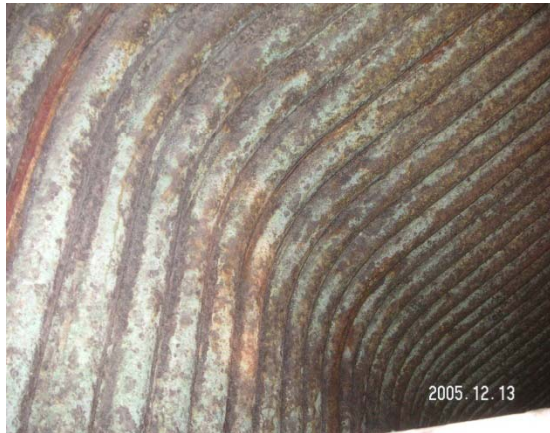
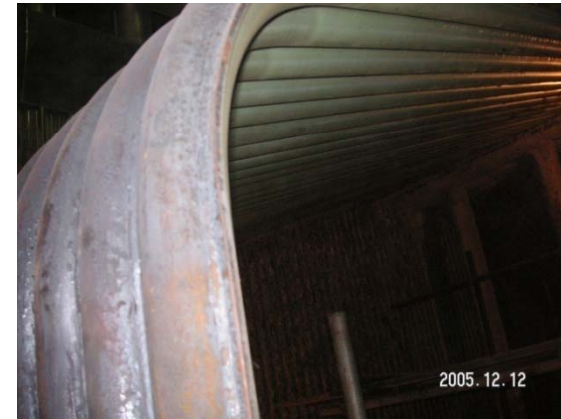
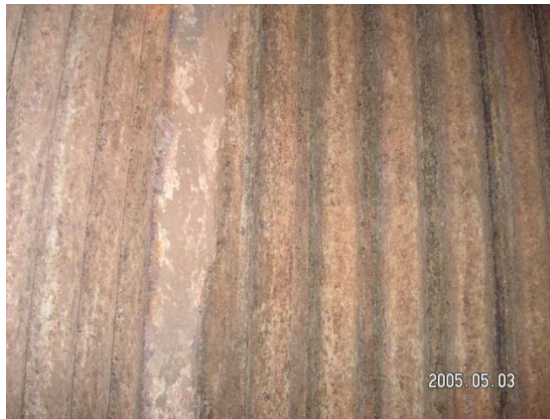
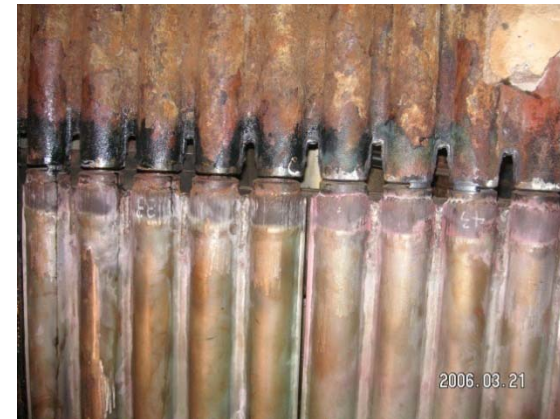
## Figure 15b: Appearance of Roof and Front Units

**Roof  
32 m  
from floor**

**Front  
Units  
30 m  
from floor**

**Units After Service**

**Units Before Service**

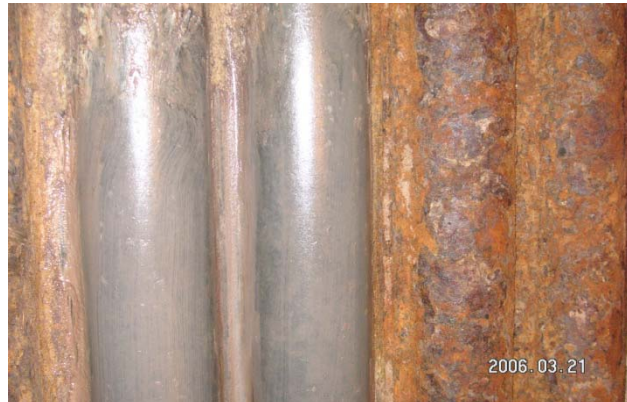
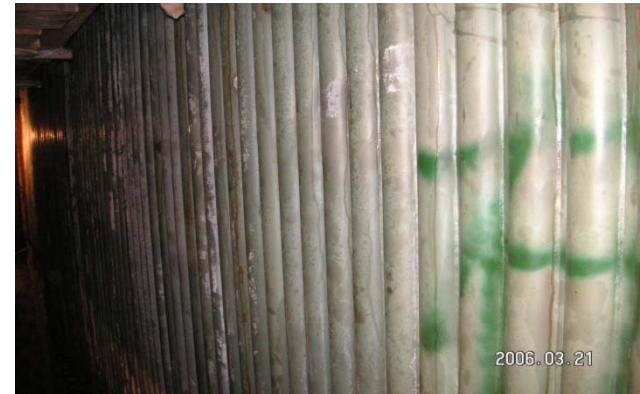
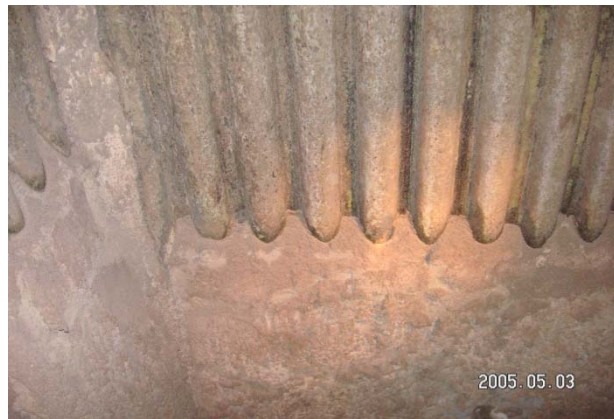
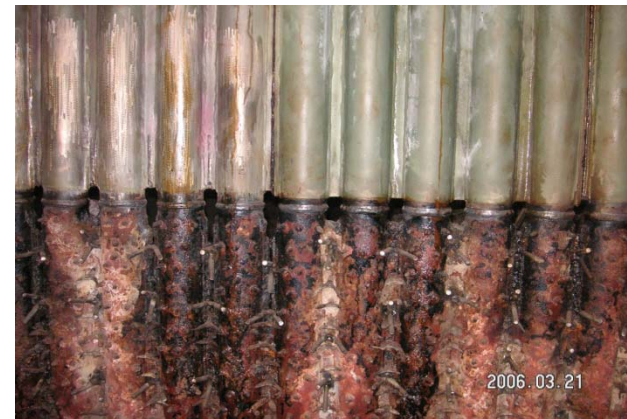
## Figure15c: Appearance of Front and Mortar Coated Units

**Front Units  
26m  
from floor**

**Front Units  
20 m  
from floor**

**Units After Service**

**Units Before Service**

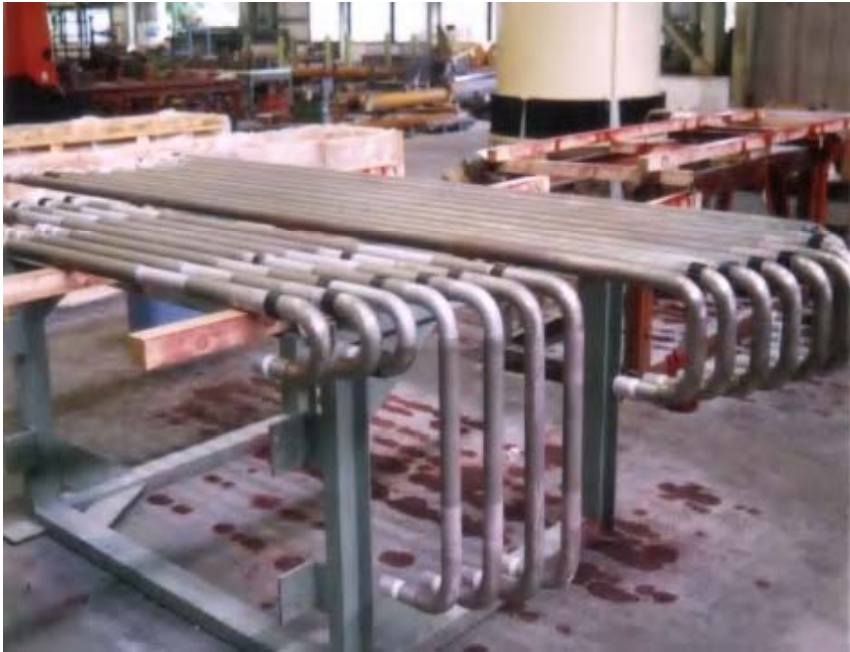
**Super Heater of Coal  
Combustion Power Plant**

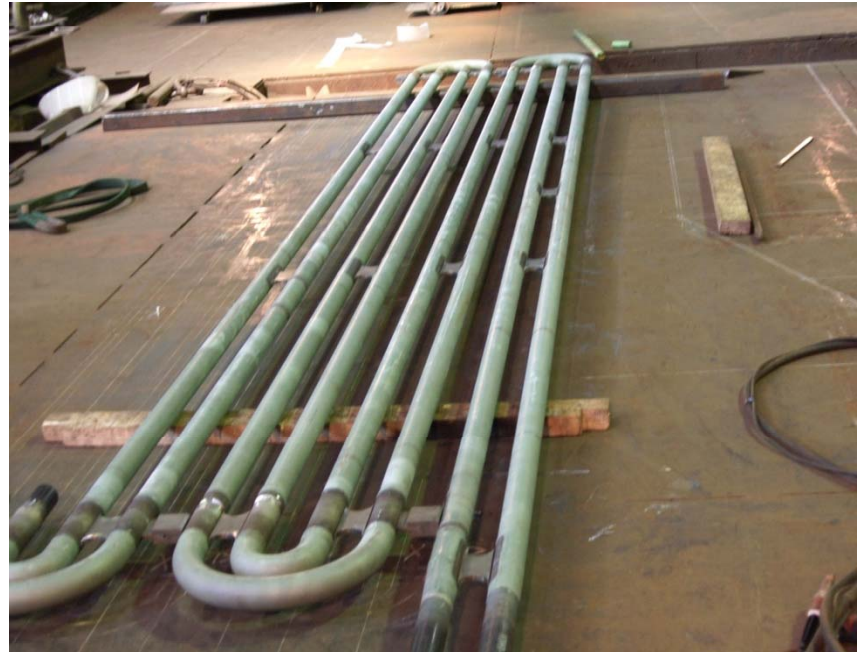
**Super Heater of Waste  
Incineration Plant**

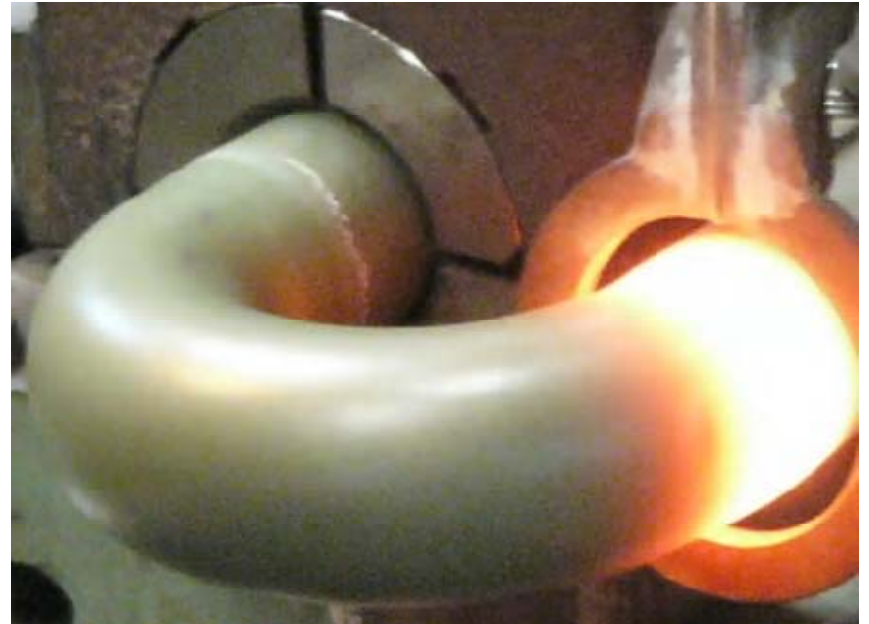
**Bent Tube-  
Induction Bending**

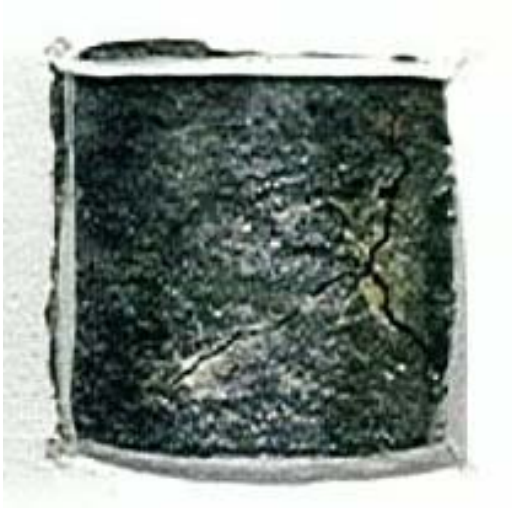
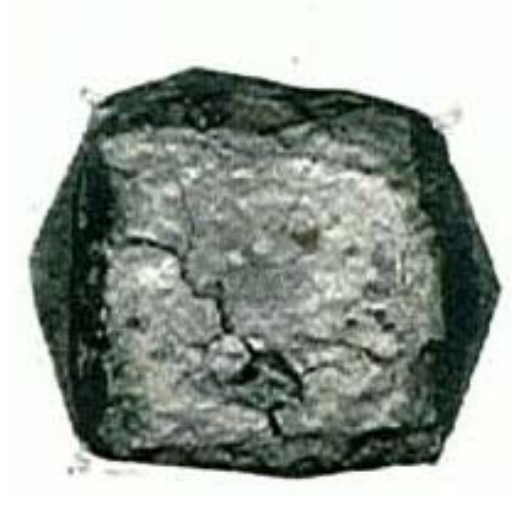
Fig.3 : Appearance of Corroded Sample  
after Testing at 923K for 72h
