FIRESIDE TUBE CORROSION IN AN INDUSTRIAL RDF-FIRED BOILER — KODAK'S EXPERIENCE

ROBERT D. BLAKLEY

Eastman Kodak Company
Rochester, New York

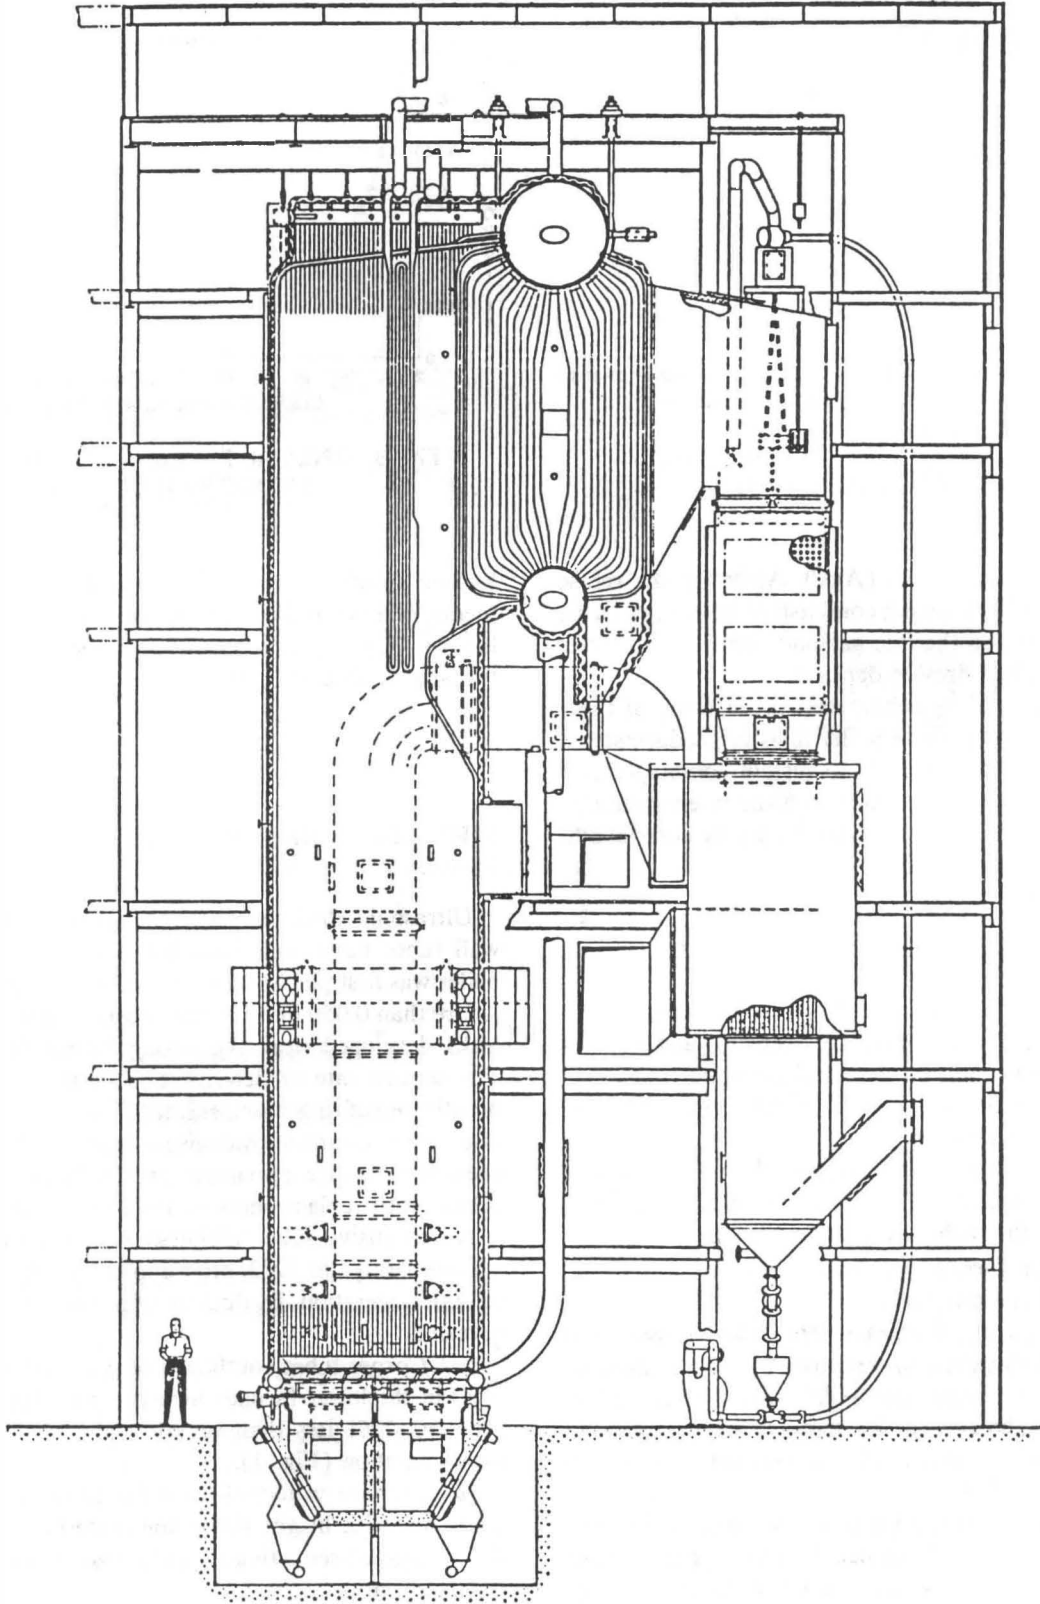
FIG. 1 ORIGINAL BOILER CONFIGURATION W/ SUPERHEATER

A radiant platen superheater, consisting of 2.125 in. × 0.203 in. M.W.T. (54 mm × 5.2 mm) SA213 T22 (2.25% Cr, 0.5% Mo) low alloy carbon steel tubes, was retrofitted to the boiler in 1973, after 3 years of saturated steam service. This raised the design outlet steam temperature by approximately 100°F (38°C) to 550°F (290°C). Figure 1 shows a sectional side elevation view of the boiler's original configuration with the added superheater.

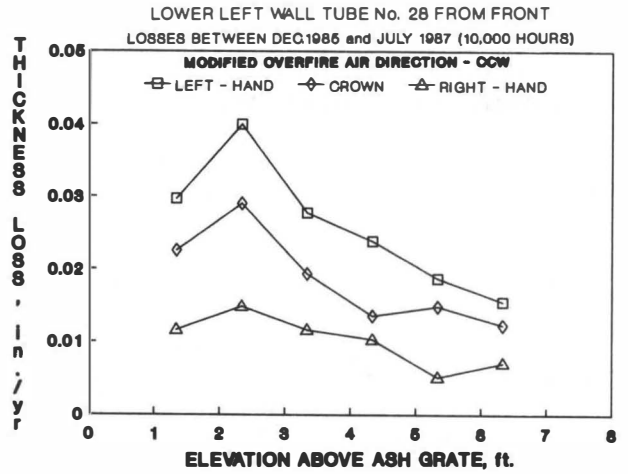
FIG. 6 STUDY TUBE, ANNUALIZED WASTAGE VS ELEVATION

even after overfire air nozzles were relocated and changed the direction of swirl from clockwise to counter clockwise (Fig. 6).

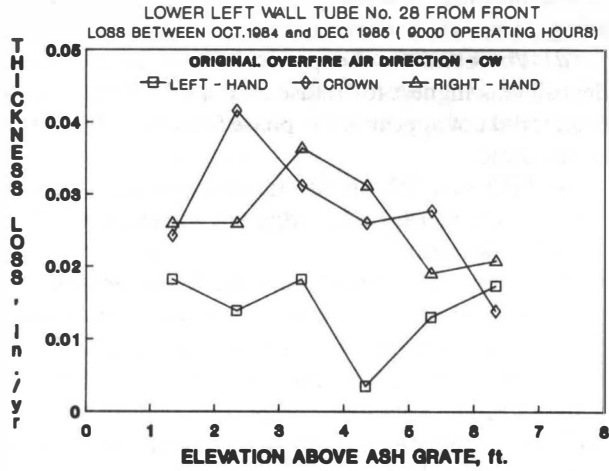
FIG. 5 STUDY TUBE, ANNUALIZED WASTAGE VS ELEVATION

Between 1984 and 1987, two individual lower furnace tubes in the left waterwall were periodically measured for thickness. The most significant finding was the pronounced wastage which occurred on the portion of the tubes' firesides facing away from the direction of overfire (OFA) air injection (Fig. 5). This continued
