Electrostatic Precipitator Maintenance Process Re-Engineering: Lead & Cadmium exposure control at the Hampton/NASA Steam Plant.

**John S. Austin, P.E.
50 Wythe Creek Road
Hampton, Virginia**

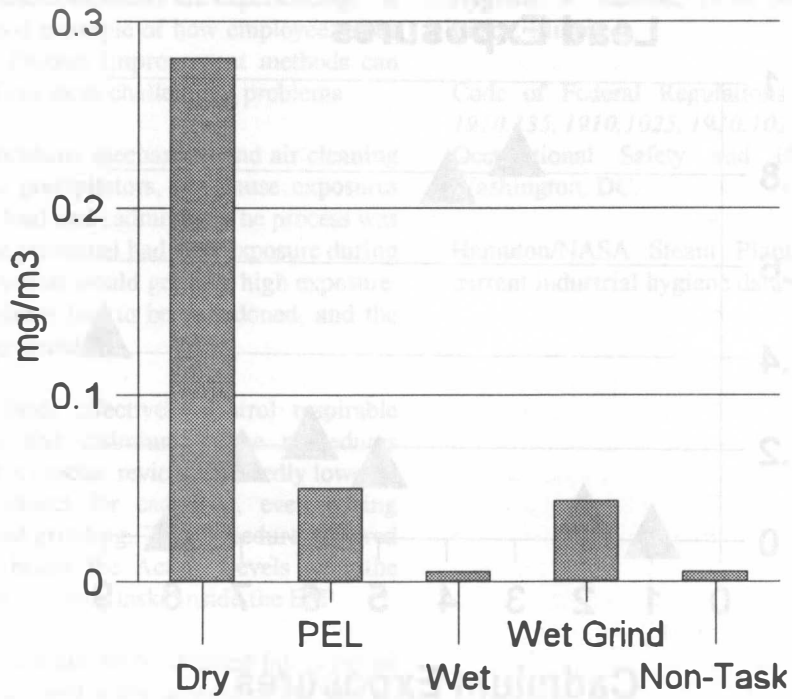
Figure 2: Lead Exposures

The results of wet methods were procedures that consistently reduce exposures during and after cleaning to below the action levels. The wet grinding procedure reduces lead levels to below the PEL, but above the action level. ESP grinding tasks are very infrequent, so it may take years to accurately quantify exposures. The summary of results are presented in Figures 2 and 3.

Most cadmium samples for the wet methods and the non-task incidental exposures were reported at a non-detect level. Time weighted averages for these varied based upon the sampling and task durations. The wet grinding procedure controls cadmium, but the lead absorbed into the metal causes lead exposure above the action level.
